09-19-2019

UCSF Building Seismic Ratings Aldea San Miguel 1

CAAN #3014

50 Johnstone Drive, San Francisco, CA 94131

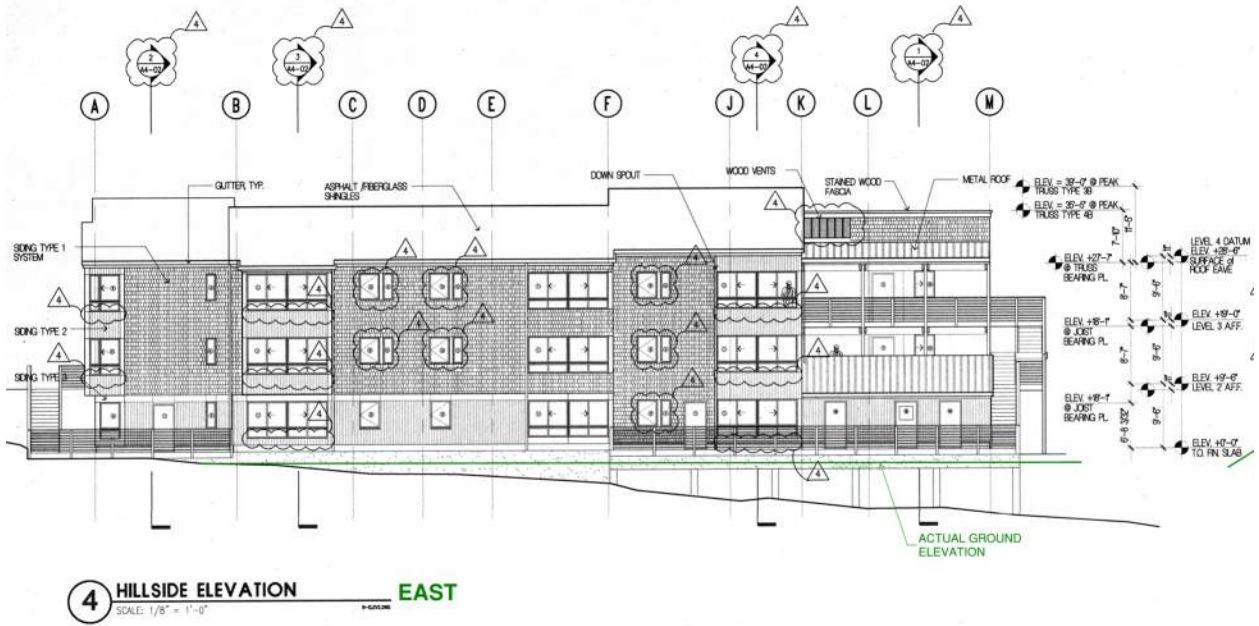
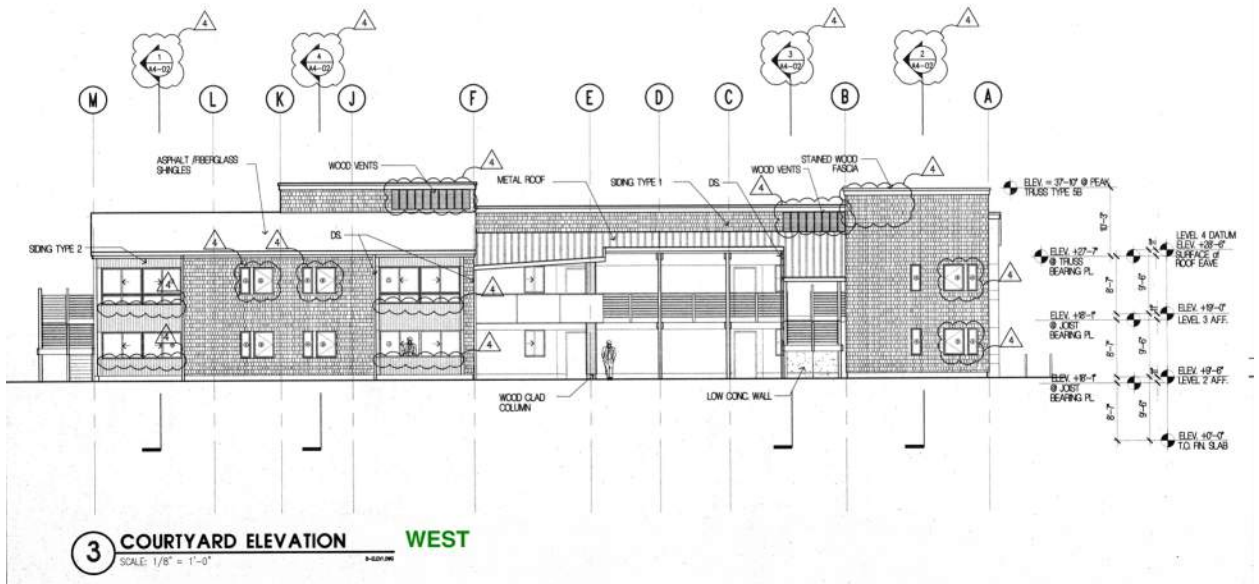
Figure 1. – Exterior Longitudinal Elevations

- On the downhill slope of the building, the exterior longitudinal walls have aspect ratios greater than 1:1 due to window openings. These walls were checked using Tier 2 procedures and verified to generally be adequate for tributary loading. Since there is considerable wall in both the transverse and longitudinal directions in the vicinity of the downhill facing wall, there is a back-up load path should the walls on the downhill side lose strength and/or stiffness.

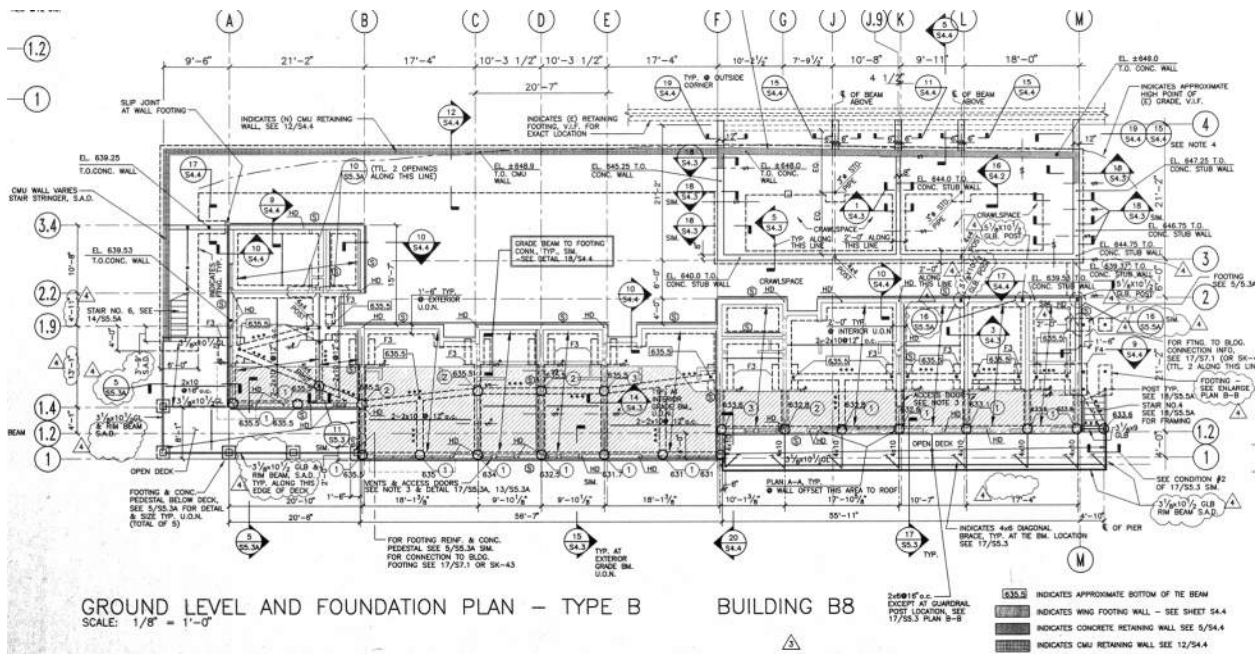
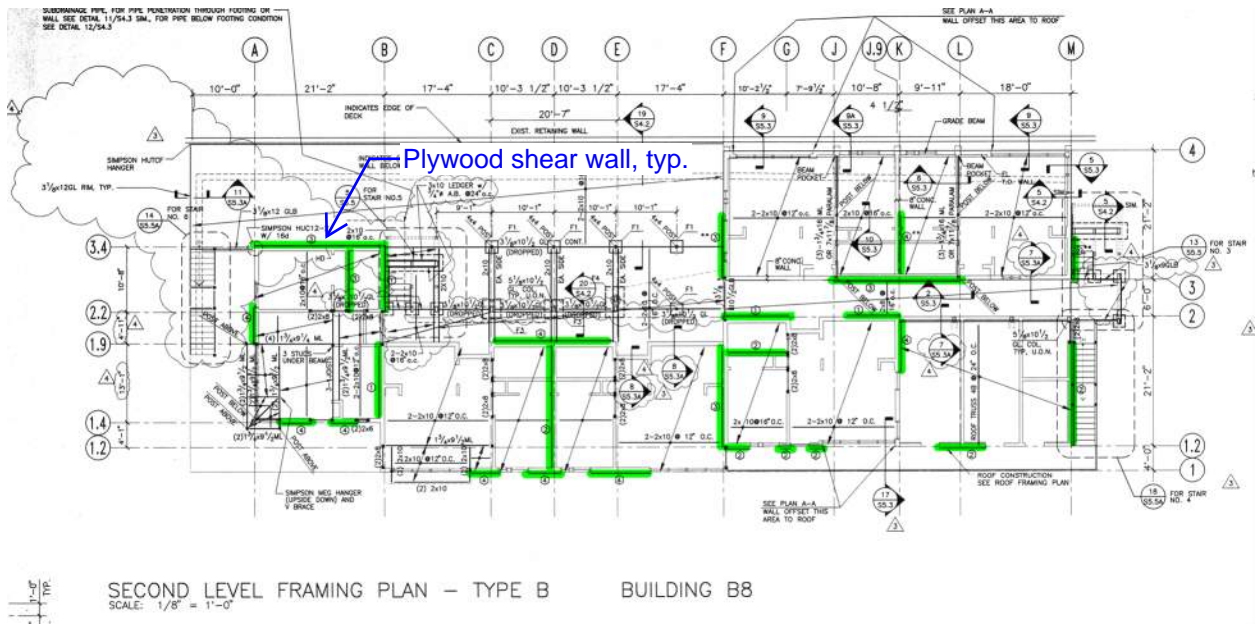
Figure 3. – Structural Foundation, Ground Level, and Second Level Plan

- In a quick check of the lateral-force-resisting system, the shear walls do not have adequate shear capacity at the second level in the transverse direction based on wall layout shown on the structural drawings. When 12 feet of additional wall shown on the architectural drawings and verified in the field is considered at level 2 there is sufficient wall to pass the quick check. The second level has the highest wall stresses from the quick check calculation. The quick check shear demand is 976 and 942 plf in the longitudinal and transverse directions respectively, compared to the quick check capacity of 1000 plf.

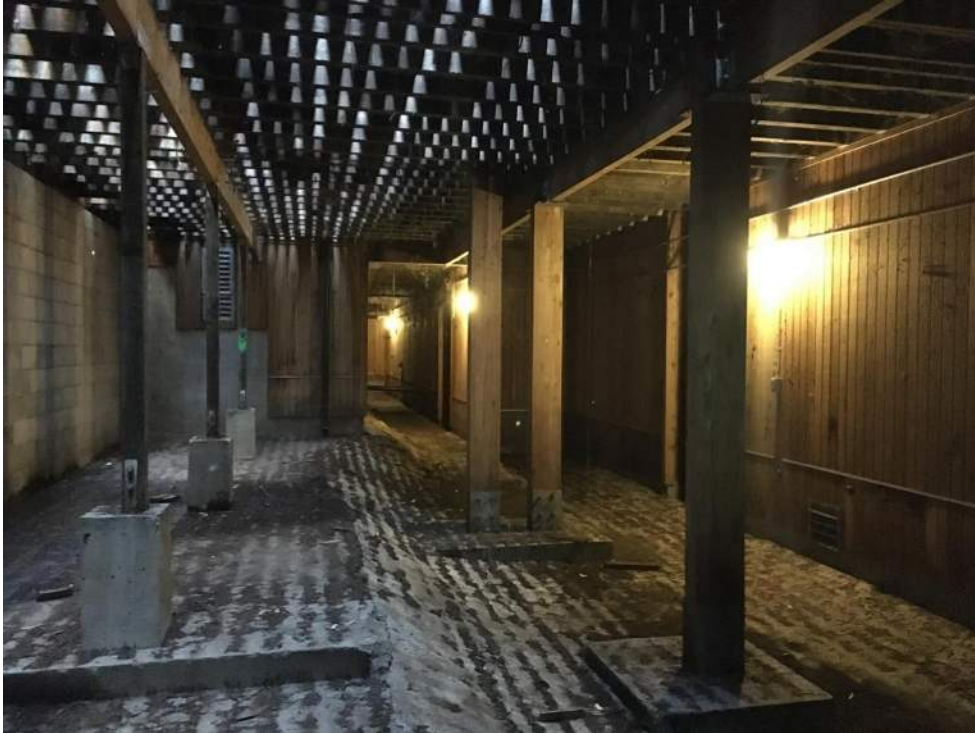
Building Condition: Good. Minor water staining of sheathing in the crawl space observed. Exterior siding is aged. Other buildings of similar age on the campus are undergoing siding replacement.

Figure 8. – Walls in crawlspace

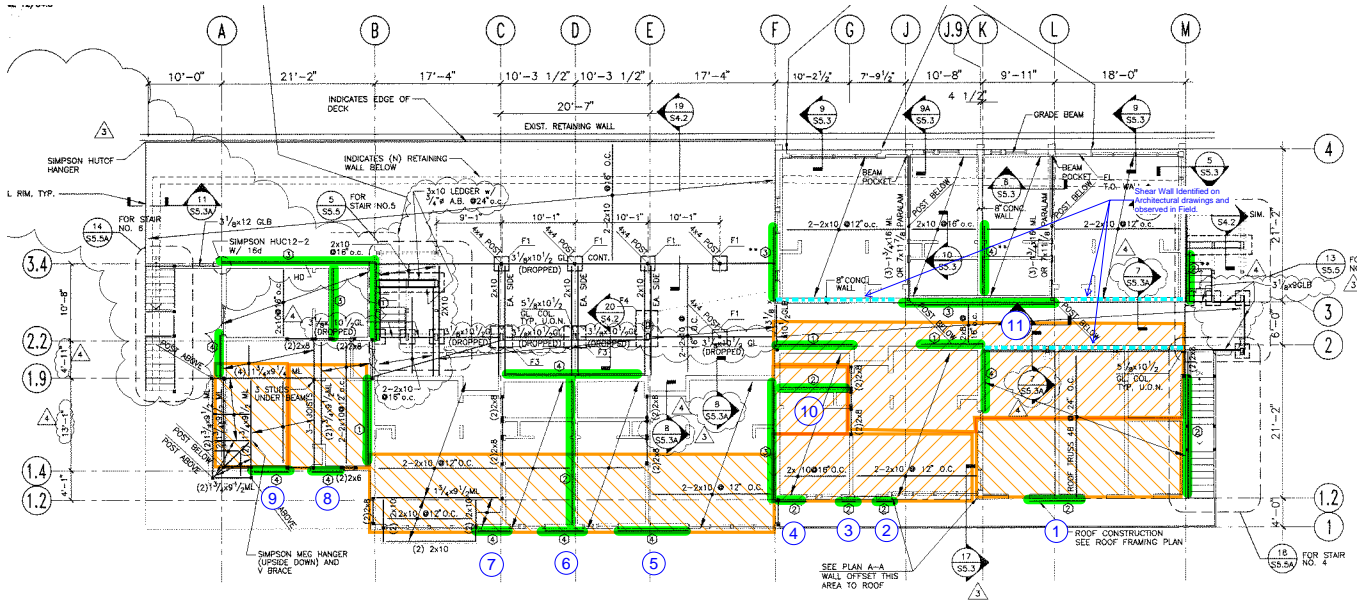
SECOND LEVEL FRAMING PLAN - TYPE B BUILDING B8
SCALE: 1/8" = 1'-0"

Wall Check - Structural Drawing Walls						
Wall Label	Wall Mark	Wall Length, ft	Tributary Area, sf	Wall Shear, plf	Wall Capacity, plf	DCR
1	2	7.6	325	4657	5225	0.89
234	2	8.5	230	6069	5225	1.16
567	4	20.5	650	7112	8870	0.80
8	4	4.75	160	7555	8870	0.85
9	4	4.75	180	8499	8870	0.96
10	1	45.6	735	2365	3402	0.70
10*	1	45.6	880	3029	3402	0.89
11	2	9.25	125	3031	5225	0.58
11**	2	9.25	207	5019	5225	0.96

PLAN WITH LOAD DISTRIBUTED TO WALL 234

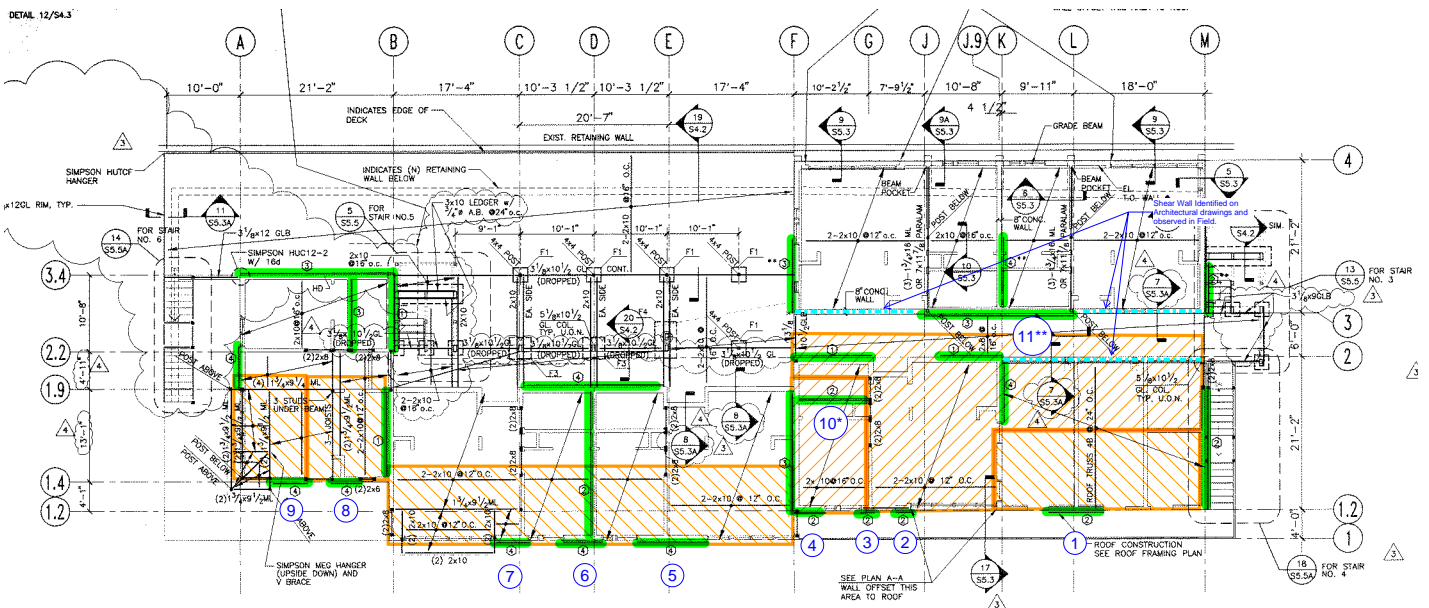
SECOND LEVEL FRAMING PLAN - TYPE B BUILDING B8
SCALE: 1/8" = 1'-0"

* - Wall 10 taking additional tributary load from wall 234 assuming wall 234 is overstressed and redistributes to Wall 10

* - Wall 11 taking additional tributary load from wall 234 assuming wall 234 is overstressed and transfers to Wall 11

PLAN WITH LOAD FROM WALL 234 REDISTRIBUTED TO WALL 10 AND 11
