Date: 2019-09-04 UCSF Building Seismic Ratings CP Ammonia Facility

CAAN# 2213 2 Medical Center Way, San Francisco, CA 94133 UCSF Campus Site: Parnassus

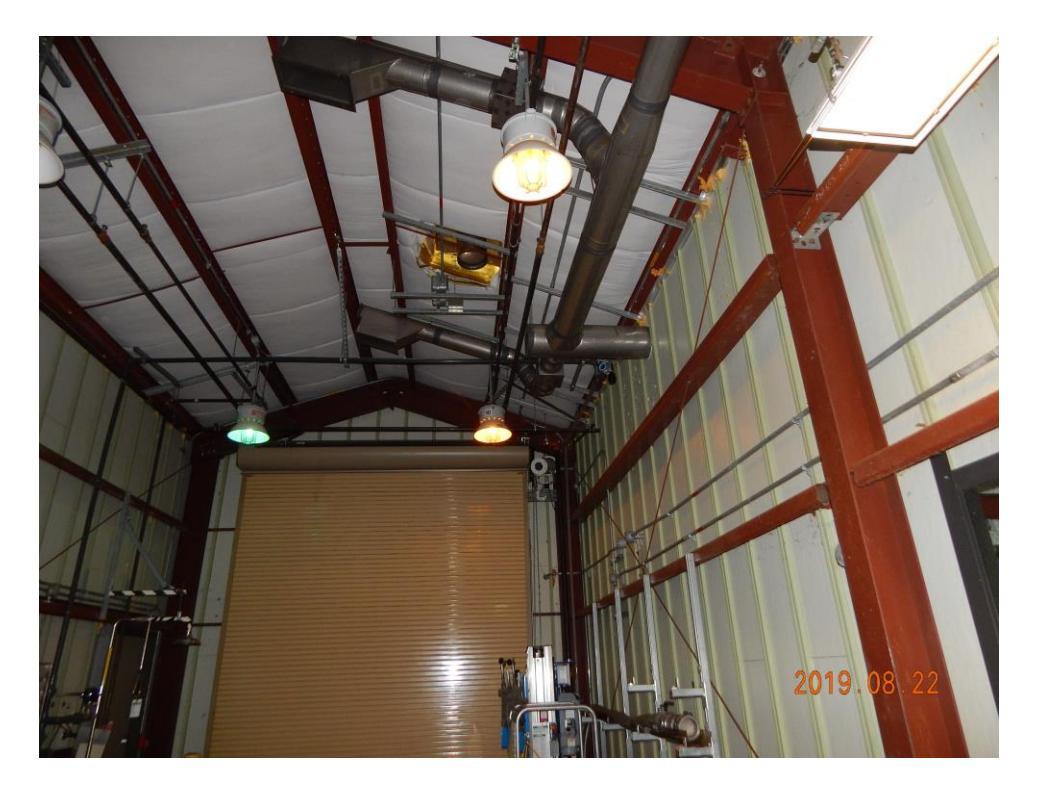
• Axial stress in rod bracing is greater than 0.5Fy assuming grade 36 rod. DCR is approximately 3.0.

Photo 4. Interior showing rod bracing.

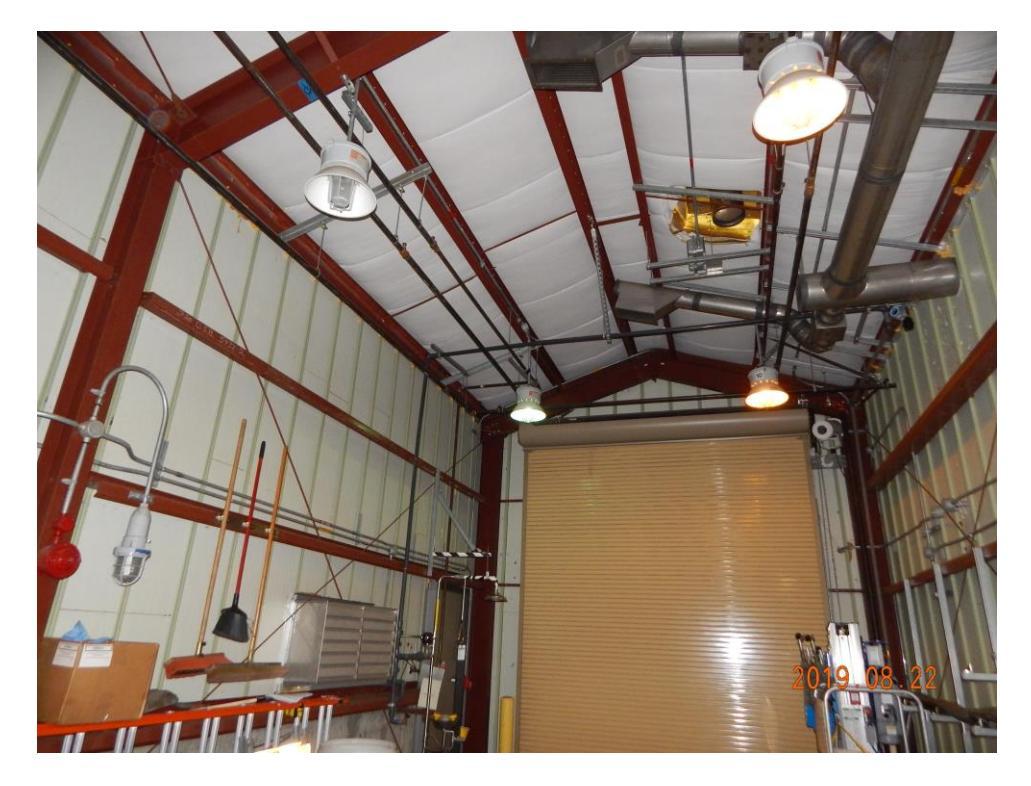
Photo 5. Interior showing rod bracing and moment connection.

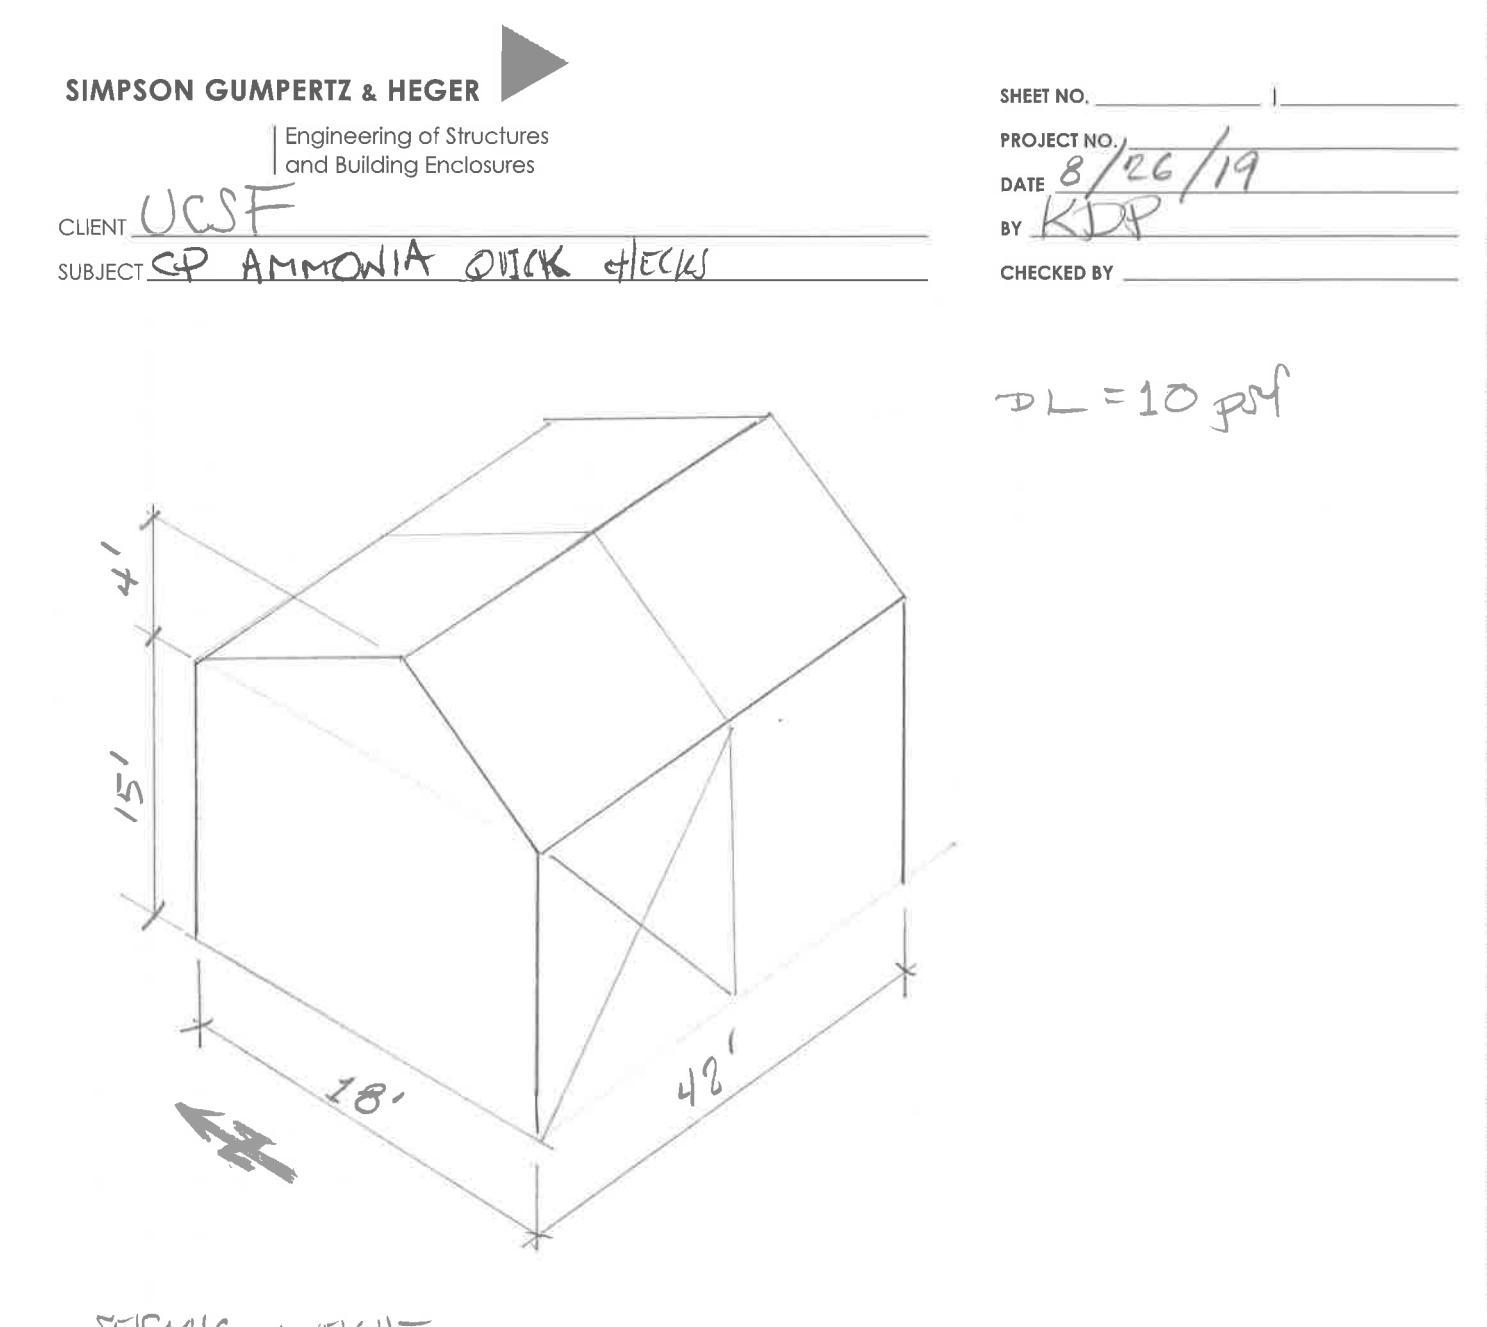
WEIGHT TRIB TO ROOF = $0.5(12.6+6.1) + 8.3 = 18^{K}$ SEISMIN TEMANIN = $CS_aW = 1.4(1.836)(18) = 45^{K}$

SIMPSON GUMPERTZ & HEGER Engineering of Structures and Building Enclosures CLIENT UCSF SUBJECT CR AMMONIA OUL(K CHECKU SUBJECT CR AMMONIA OUL(K CHECKU TOENTAWO ON N&S LINES = 45/2 = 22.5^K TOO BERAFING $H_2^{"}\phi$ $H_3F_y = \pi(0.5)^2(36) = 7.1^K$ < 22.5^K IGNOVING TOENTATIONNO GOOD
