08-06-2019

UCSF Building Seismic Ratings
Aldea San Miguel 7

CAAN #3025
95 Behr Avenue, San Francisco, CA 94131
UCSF Campus: Parnassus

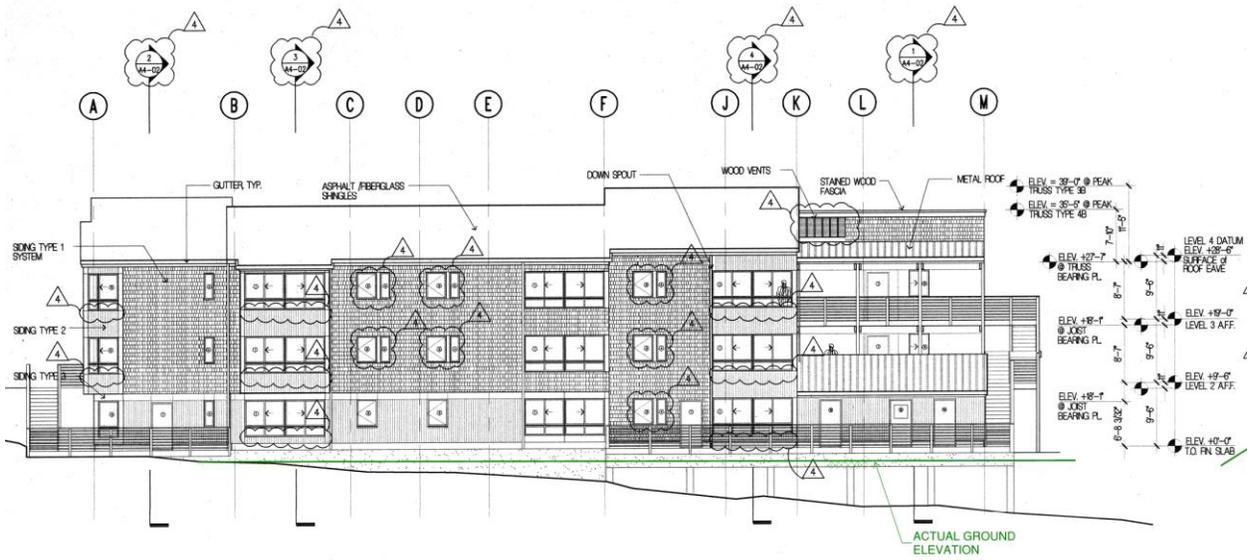
4 HILLSIDE ELEVATION EAST
SCALE: 1/8" = 1'-0"

- In a quick check of the lateral-force-resisting system, the shear walls do not have adequate shear capacity at the second level in the transverse direction based on wall layout shown on the structural drawings. When wood shear walls are included as shown on the architectural drawings there is sufficient wall to pass the quick check.
- On the downhill slope of the building, the exterior longitudinal walls have aspect ratios greater than 1:1 due to window openings. There is significant wall along the south side of the crawl space, which resists torsion due to the hillside site.

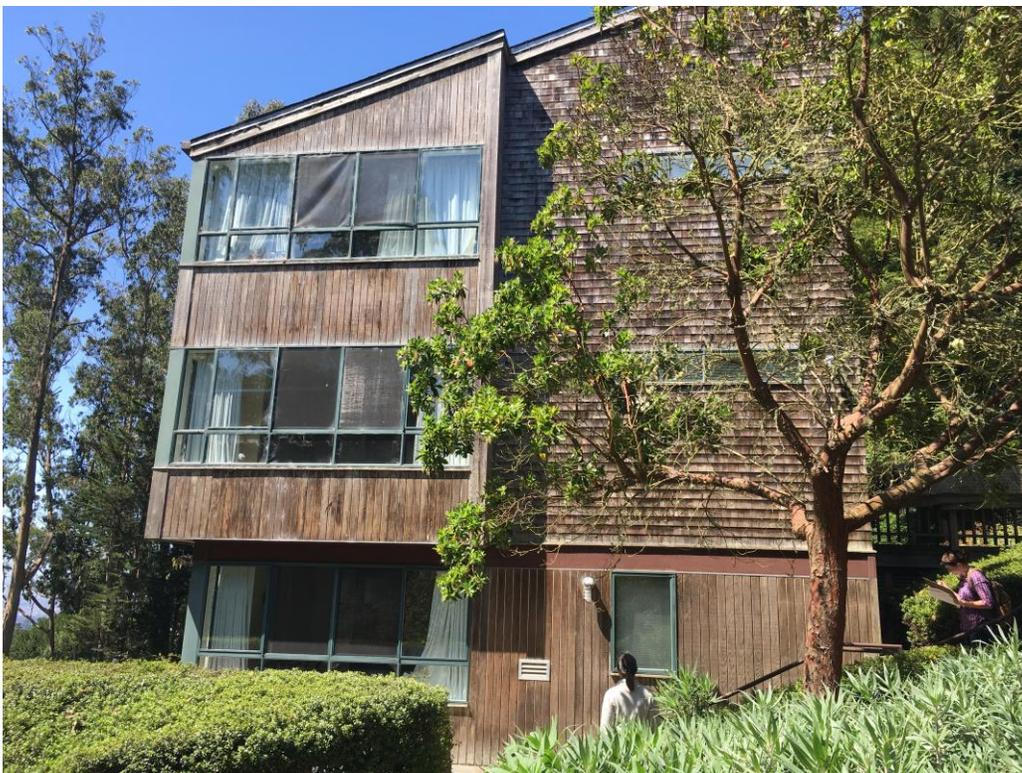
Figure 8. – East elevation

Building Condition: Good. Minor deterioration was observed in the existing siding at the south-east corner of the building.
