**UCSF Building Seismic Ratings**  
**1472-74 5<sup>TH</sup> AVENUE**

CAAN #2029

1472-74 5<sup>th</sup> AVENUE, SAN FRANCISCO, CA 94122

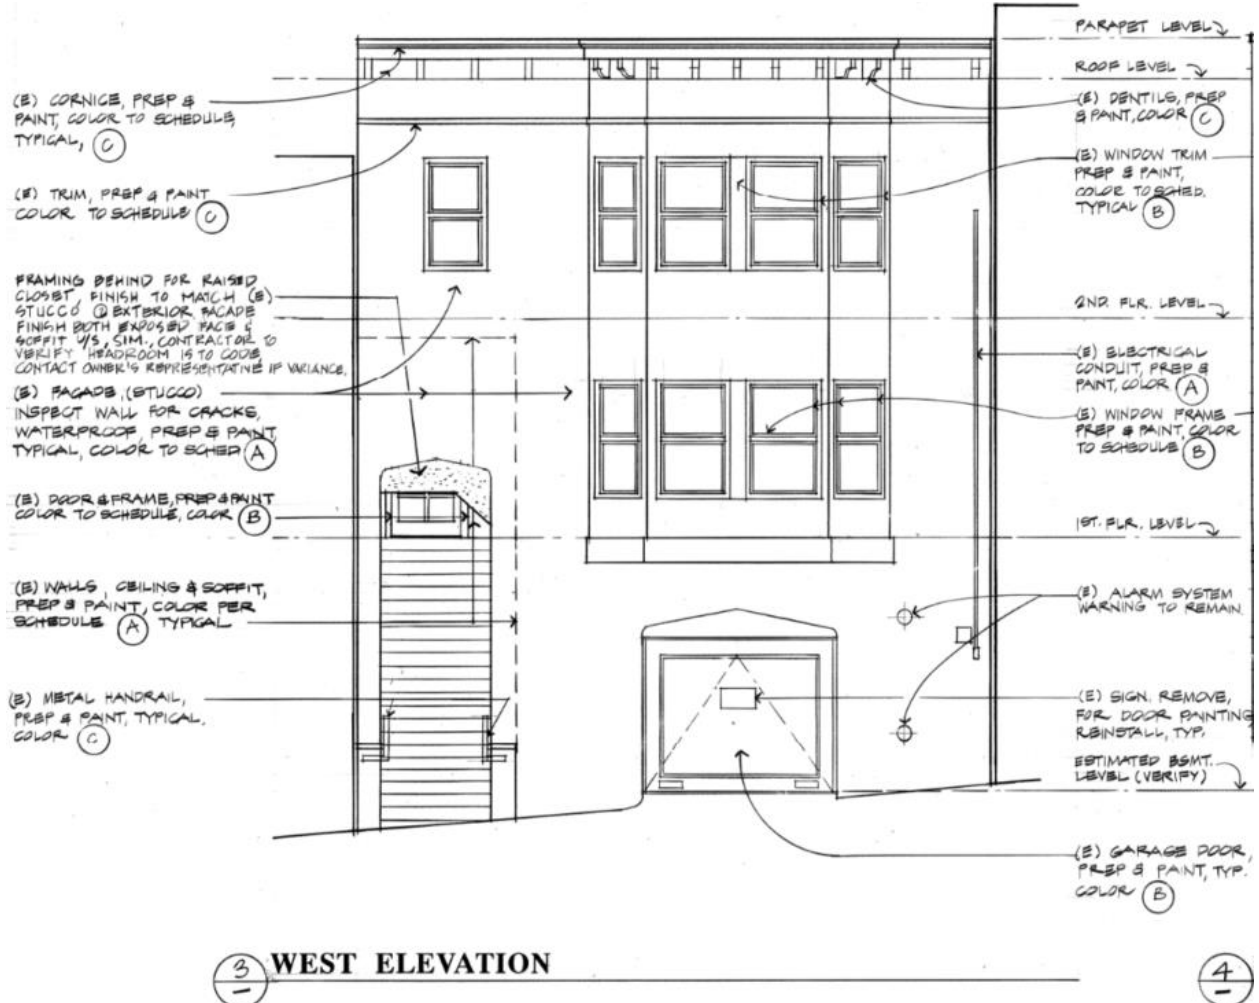
Figure 4 - Exterior Elevation (West Elevation)

Building Condition: What could be observed of the structure of the building appeared to be in fair condition; however, much of the structure was concealed behind finishes. The concrete slab in the basement was in good condition. No cracks in the exterior stucco were found.

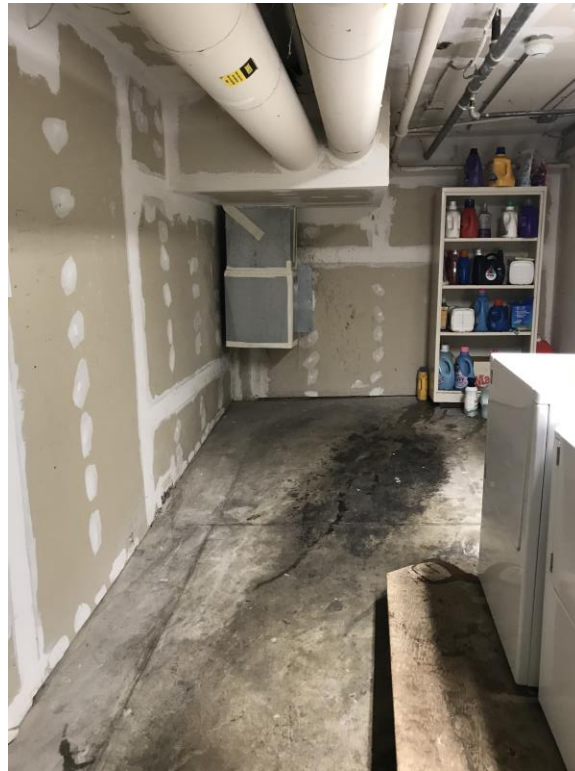
**Figure 6 – Basement Laundry Room**

The basement storage includes multiple flammable storage cabinets that may not be restrained. A container of Noxon Metal Polish, which is a flammable liquid, was observed on an open shelf, outside of the storage cabinet. Several cleaning products were also stored on open shelves.
