DATE: 2019-10-10

UCSF building seismic ratings
Mount Zion Building P

CAAN #2034

2375 Post Street, San Francisco, CA 94115

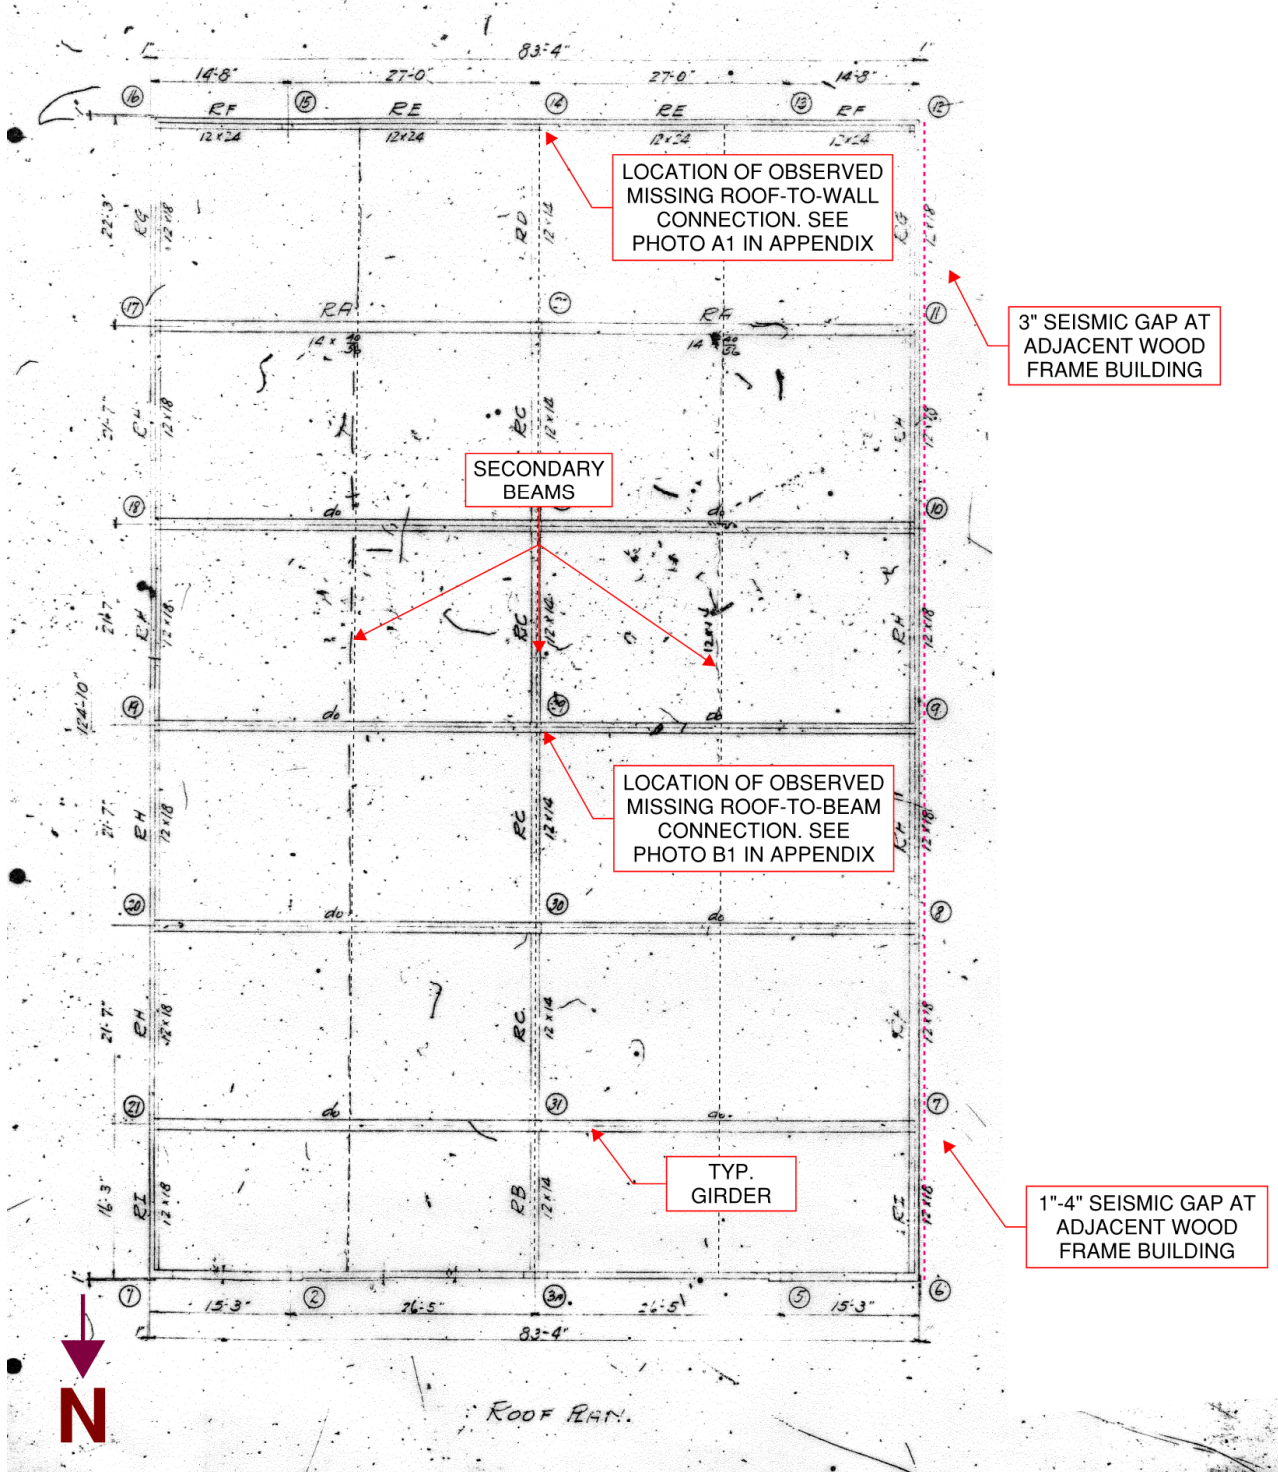
Lateral force-resisting system at roof

The wood framing located at the roof is currently bearing on the concrete beams and girders with no attachment between the two materials to transfer in-plane forces. As such, the building relies on friction as a lateral load transfer mechanism. Similarly, the roof diaphragm does not offer out-of-plane anchorage for the walls. The 6" thick walls do not have sufficient capacity to cantilever above the 2nd floor slab. When checked under this load condition, they are severely overstressed.

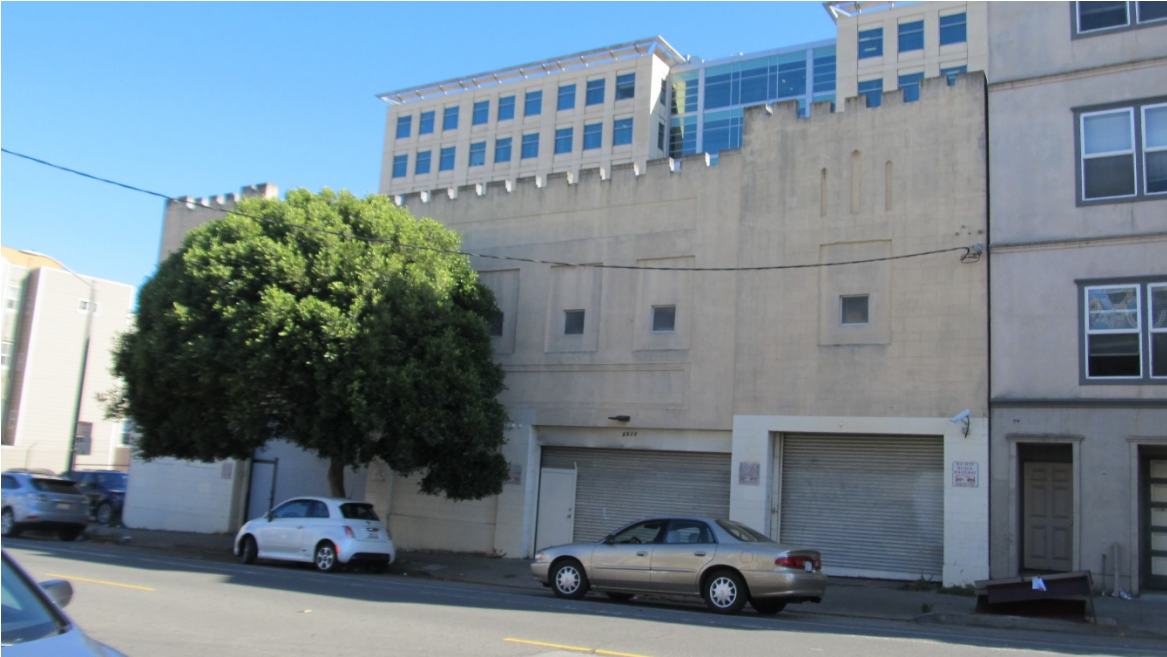
North elevation (looking southeast)

In addition, there are other, less significant seismic deficiencies. The wall located on the north elevation between the 1st and 2nd floor is 6" thick with 12" thick wall piers located between large window and door openings. The cross-sectional area of this wall is 45% of the wall located on the south elevation. As such, the center of rigidity will shift towards the south wall and the structure likely contains a torsional irregularity in the transverse direction.

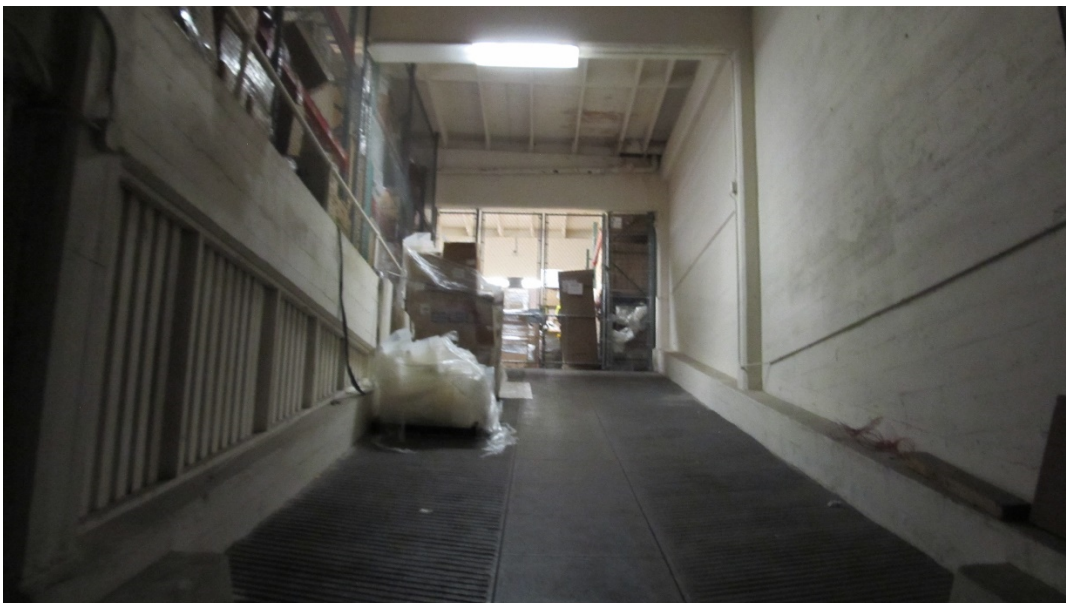
A hollow clay tile partition was observed above the entry ramp between the 2nd floor and roof. Although there are exits to the exterior at both the 1st and 2nd floor; the ramp is the only interior connection between the floors.

Ramp up to the second floor (looking south)
