## UCSF Building Seismic Ratings

### 1442 5<sup>TH</sup> AVENUE

CAAN #2046

UCSF Campus: Parnassus

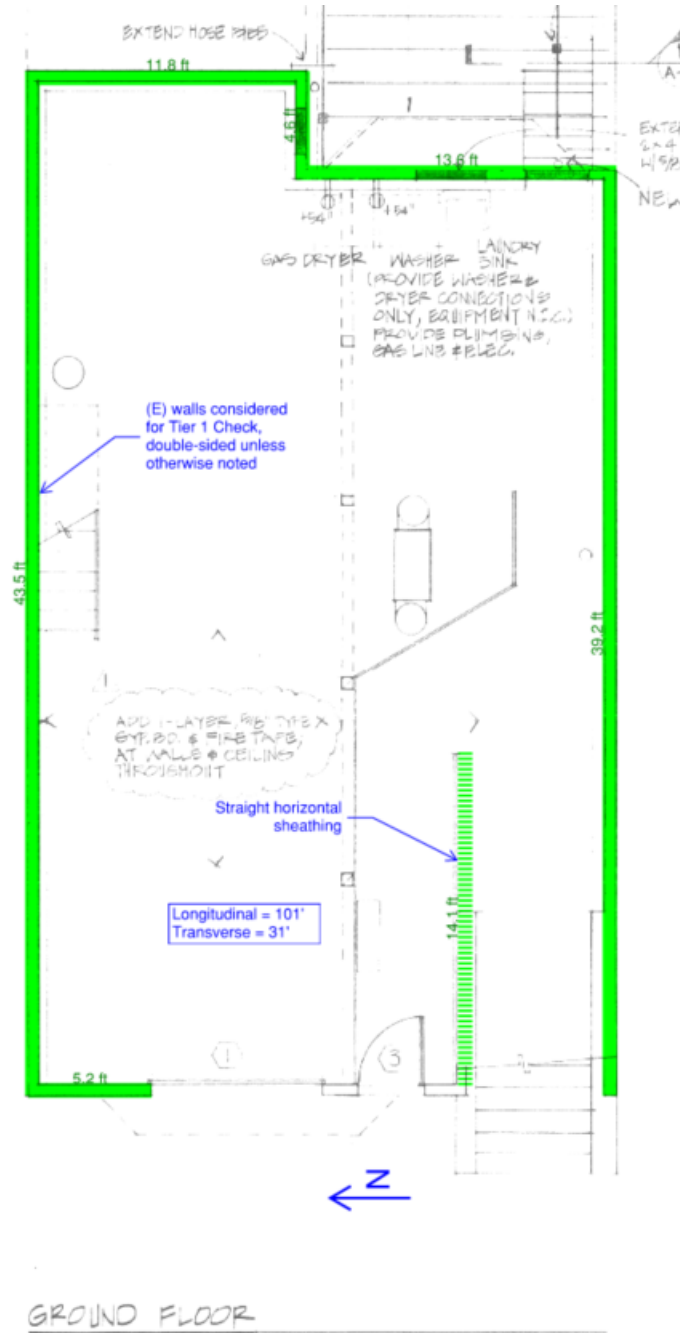
Figure 1 - Basement/Garage Floor Plan

Foundation system: Existing foundation drawings are not available. It is presumed there are continuous footings below bearing walls. During the site visit on December 10, 2019 continuous concrete stem wall footings were observed around the ground floor level. The rear portion is supported on wood posts on isolated footings at the two eastern-most corners.

Building Condition: What could be observed of the structure of the building appeared to be in fair condition; however, most of the structure was concealed behind finishes. The concrete stem walls in the utility space were poorly consolidated in many areas and some spalling was observed. The wood siding, trim, and rear wood exterior patio and stairs looked to be in good condition. The building underwent a renovation in 1988, which was mostly cosmetic in nature.
