UCSF Building Seismic Ratings

1464 5TH AVENUE

CAAN #2054

1464 5th AVENUE, SAN FRANCISCO, CA 94122

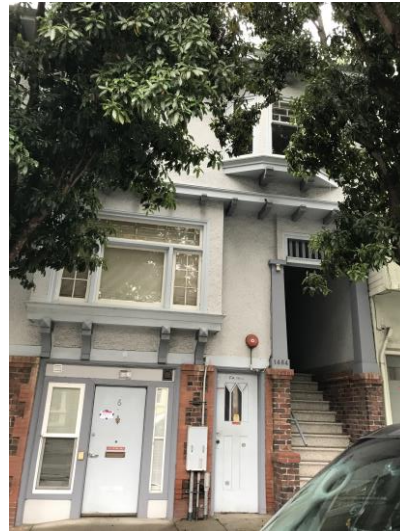
West Elevation

Building Condition: What could be observed of the structure of the building appeared to be in fair condition; however, all of the interior structure was concealed behind finishes. The wood siding, trim, and rear deck looked to be in good condition. The stucco on the street-side wall was in good condition, with no visible cracking.
