## UCSF Building Seismic Ratings

### 1420 5<sup>TH</sup> AVENUE

CAAN #2061

1420 5<sup>TH</sup> AVENUE, SAN FRANCISCO, CA 94122

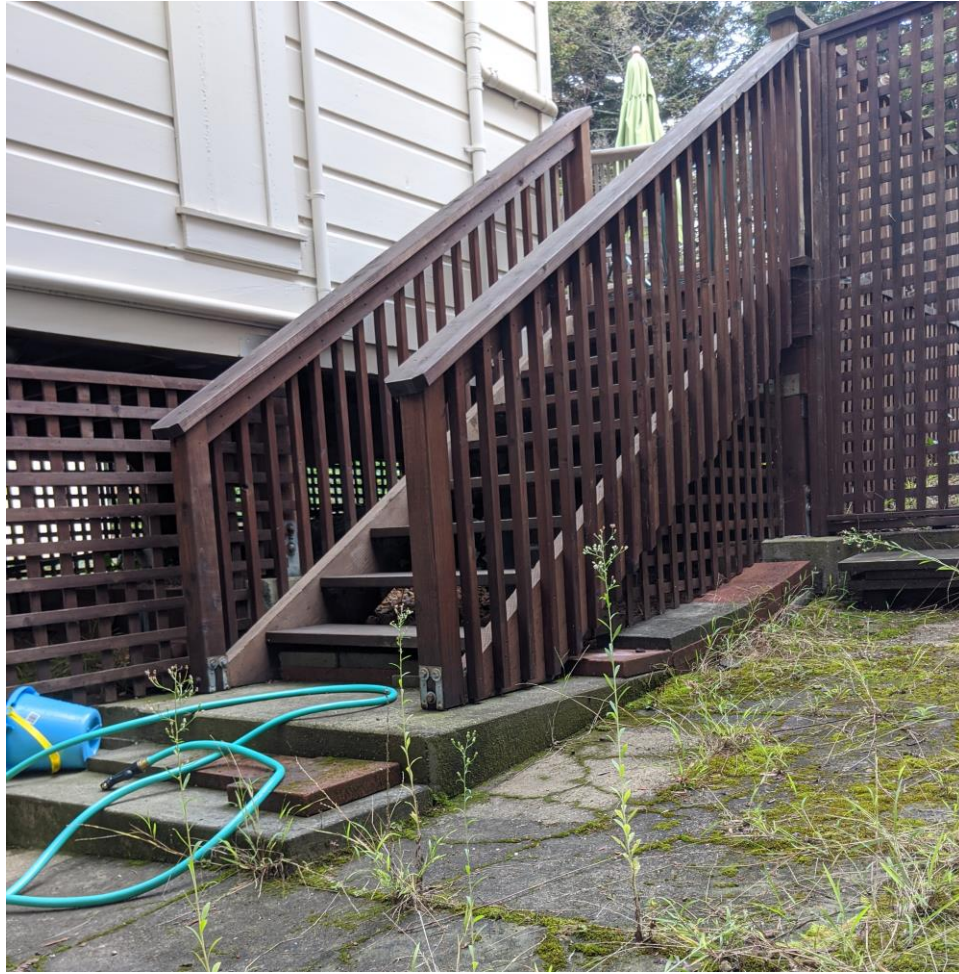
**Figure 15 – Deck Stairs Adjacent to Elevated Porch**

Building Condition: What could be observed of the structure of the building appeared to be in fair condition; however, most of the structure was concealed behind finishes. The concrete stem walls were in good condition. The side and rear wood siding and front stucco were in good condition. The rear deck and stairs were in good condition.
