UCSF Building Seismic Ratings
1422-24 5th AVENUE

CAAN #2062

1422-24 5th AVENUE, SAN FRANCISCO, CA 94122

UCSF Campus: Parnassus

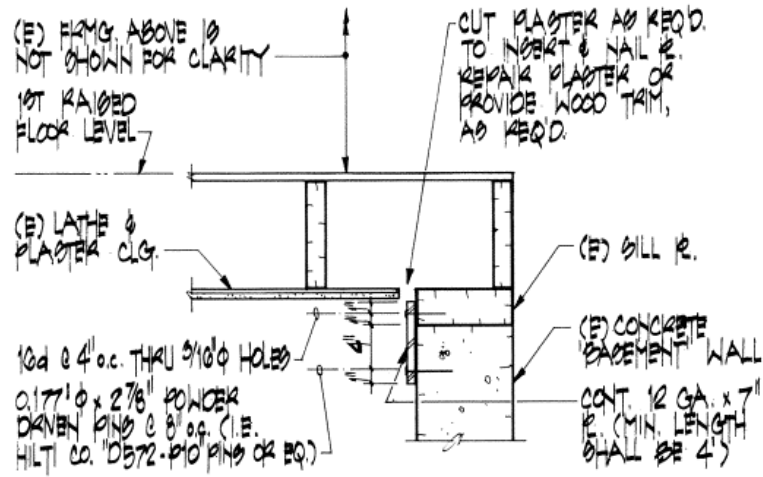
Figure 5 - Shear Tie at Concrete Walls

7 SHEAR TIE - (E) FLR. TO
S2 (E) CONC. WALL 1"=1'-0"

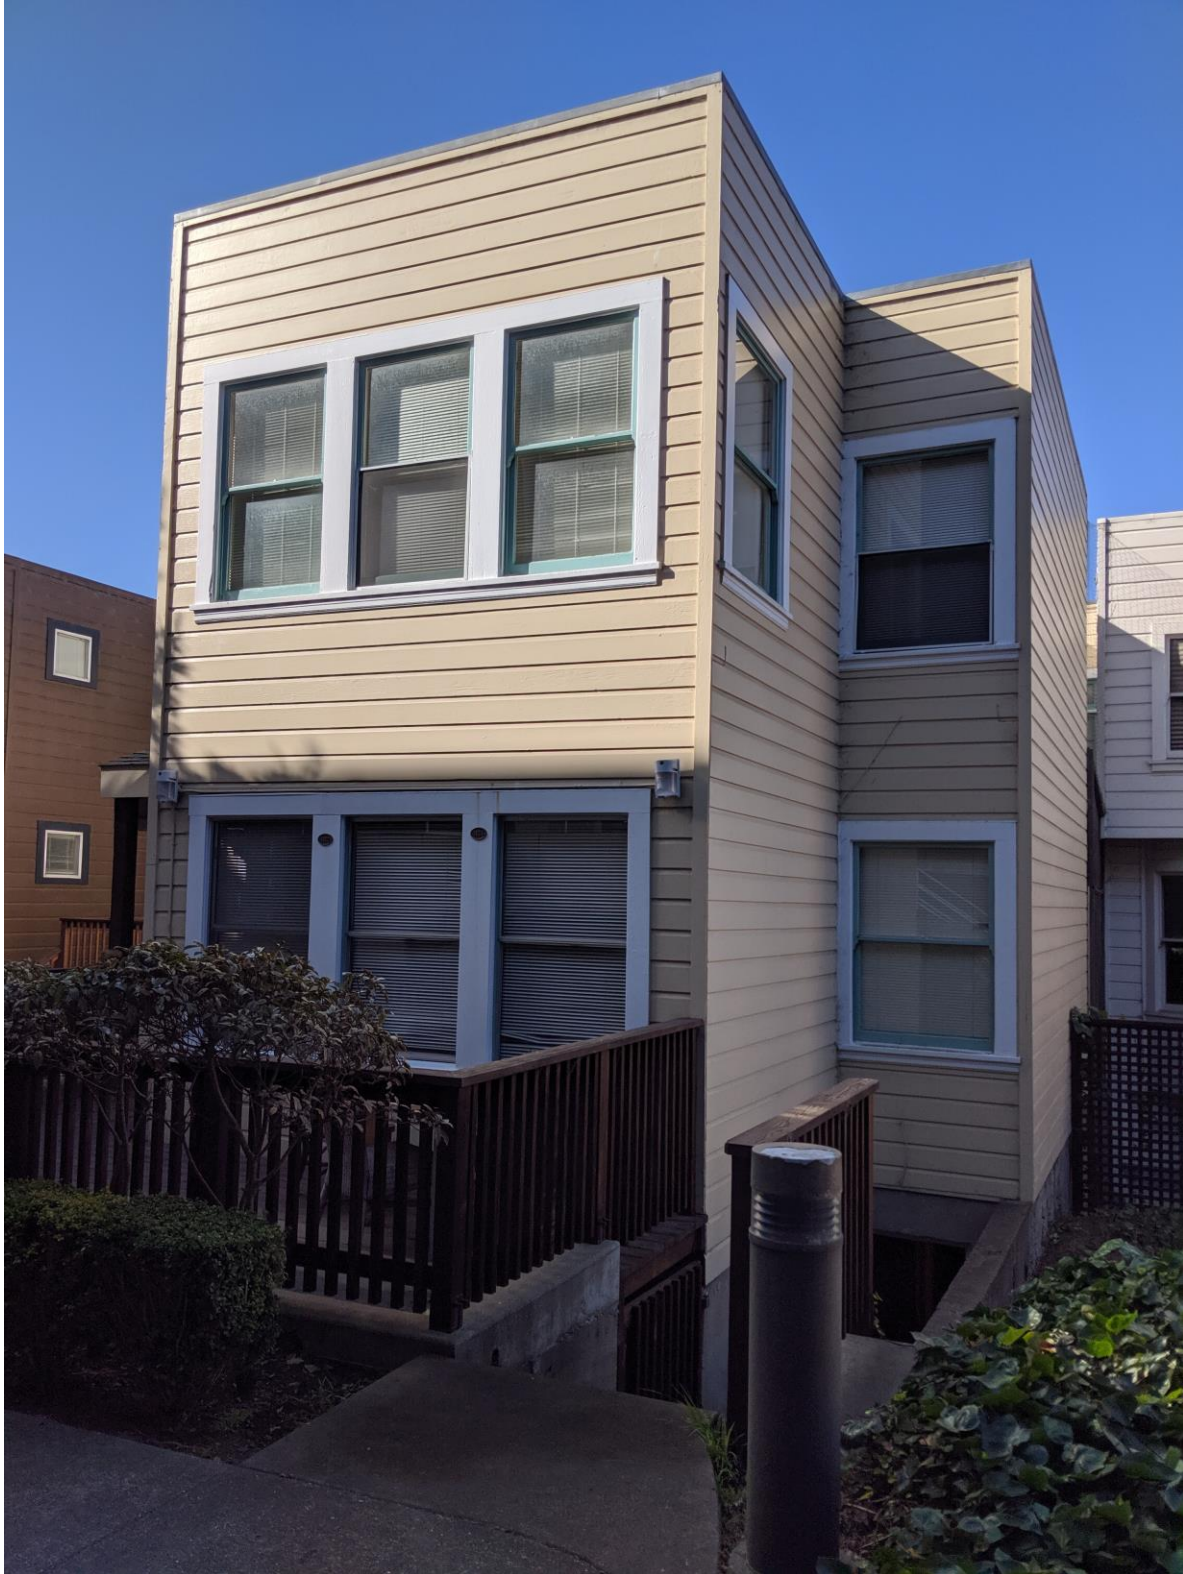
Figure 12 - East Exterior Elevation

The existing drawings show a fireplace at the first and second level. A sheet metal flue was observed extending above the roof from the street. The facilities maintenance technician assisting with our site observation stated that the fireplaces have been blocked off and are not used.
