DATE: 2019-06-25

**UCSF building seismic ratings**  
**Proctor Foundation**

CAAN #2246

95 Kirkham Street, San Francisco, CA 94122

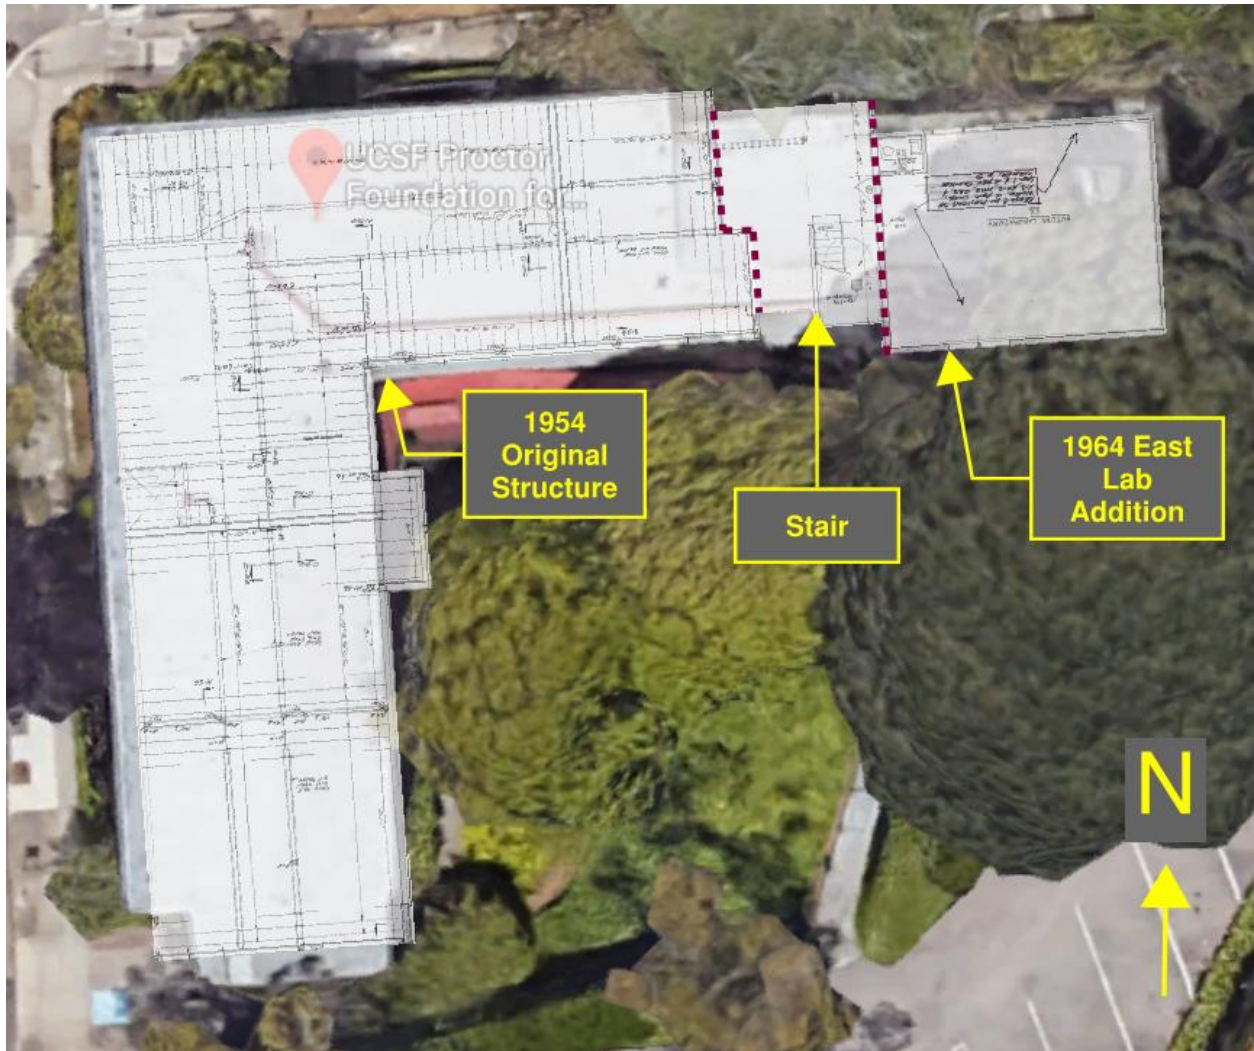
2<sup>nd</sup> floor plan

The 1954 construction of the Proctor Foundation relies on the exterior wood sheathed shear walls as the primary lateral load-resisting elements. The extent of the window openings in these walls greatly reduces the overall shear capacity, and the building relies on tall narrow end wall piers to resist the majority of the load. These piers have story height-to-length aspect ratios on the order 2.35H:1L and overall height-to-length aspect ratios approaching 4.6H:1L. With these proportions, it is expected that the overturning forces in the piers will be high. Although some tie down anchors are located in transverse direction walls, the end wall piers typically do not contain wood post boundary elements and tie downs. In 1964, an additional story was added onto the original structure. This addition utilizes interior shear walls along the central corridors in addition to the exterior shear walls. The corridor walls at the upper story align with existing stud walls below; however, the stud walls below do not contain plywood sheathing. The walls between the 2<sup>nd</sup> and 3<sup>rd</sup> floors may help resist overturning loads from the shear walls above, but they do not help resist the shear forces. Due to the interior shear walls in the upper, but not the lower story,

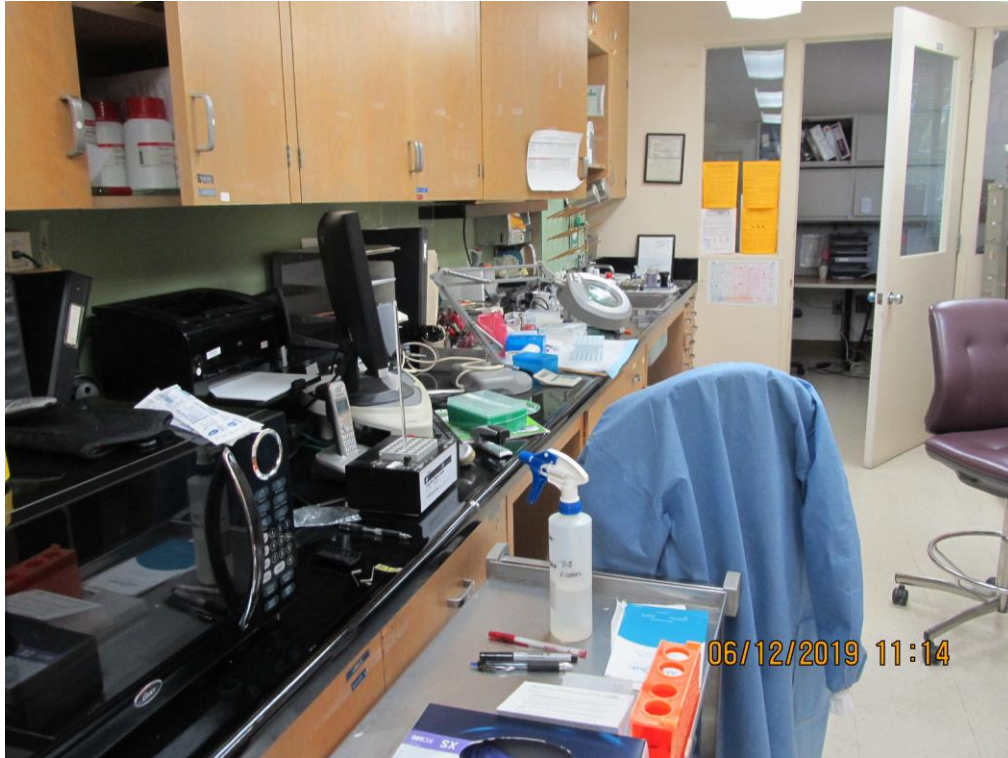
Lab interior

The majority of the lab equipment is unbraced including, but not limited to, refrigerators and fume hoods. Gas supply to the building is unknown as the boiler room was not accessible. No gas fueled equipment was observed; however, a gas meter is located on the north elevation. Access to the mechanical room was not available during the site visit.

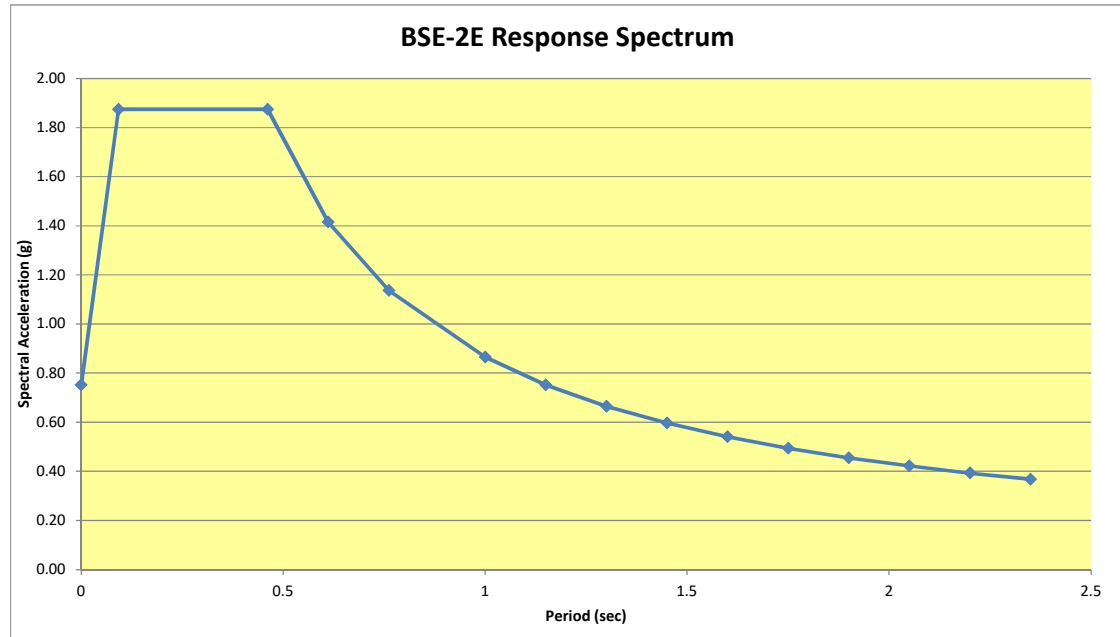
#### East Lab from 1964 Alteration

$T = 0.20 \text{ s}$   
 $S_a = 1.87 \text{ g}$  (See Note 2)  
 Tier 1  $S_a = 1.88 \text{ g}$  (See Note 3)
