**UCSF building seismic ratings**

**Oyster Point**

CAAN #2418

612 Forbes Boulevard, South San Francisco

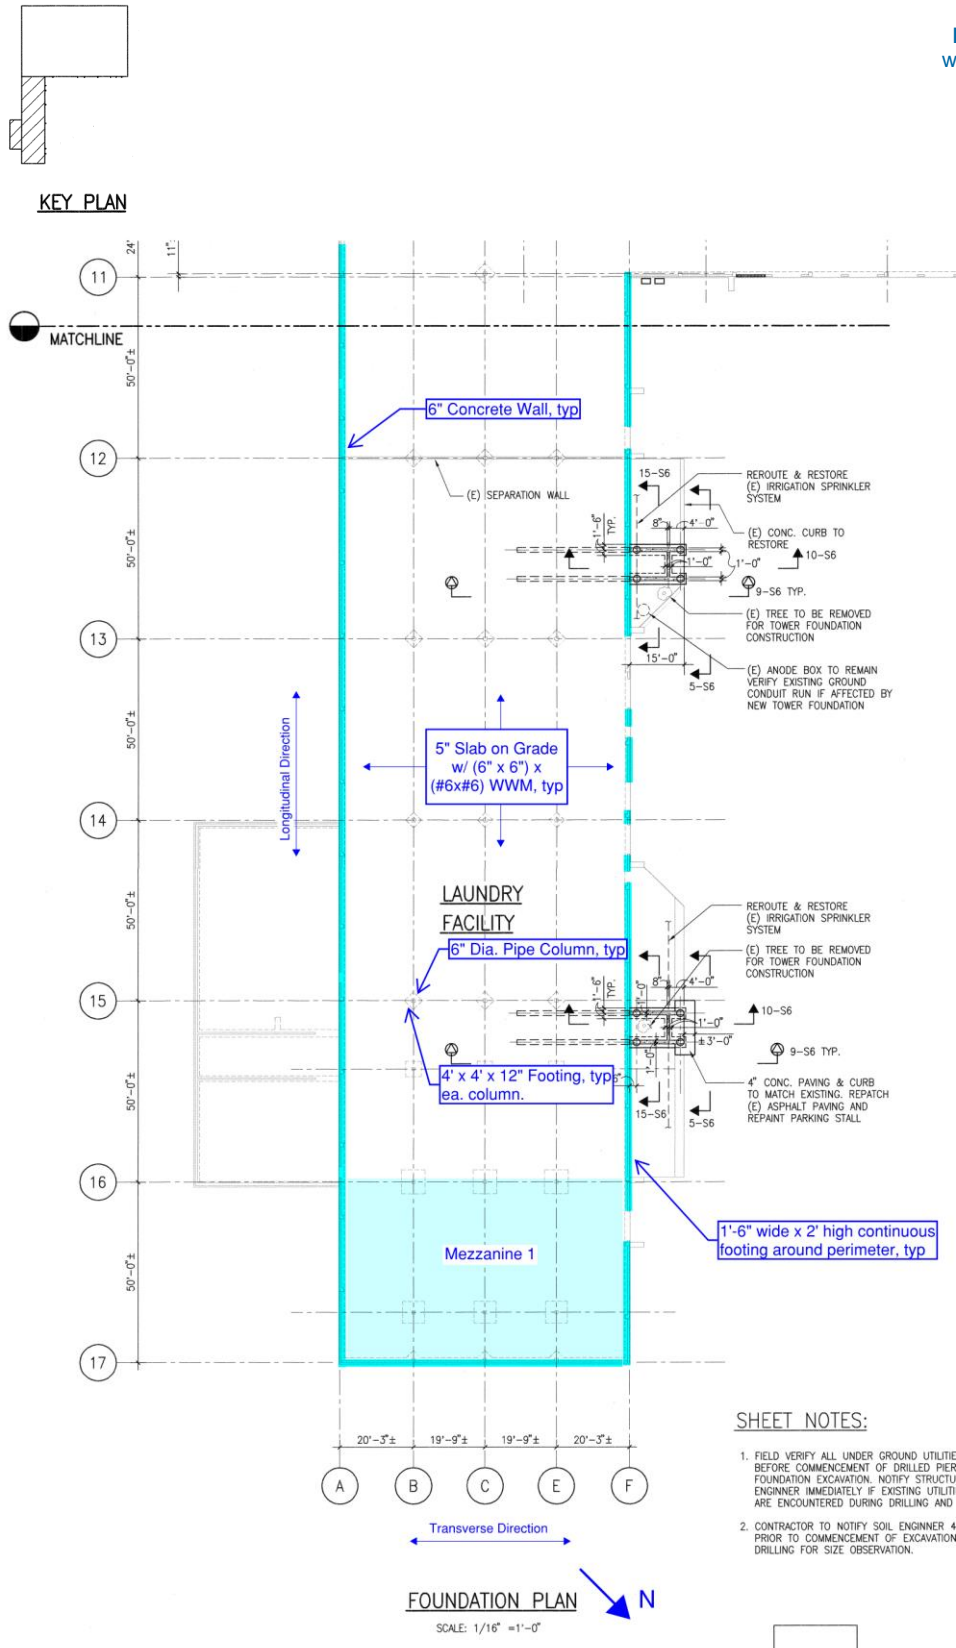
Figure 2 - Foundation Plan (2 of 2)

The building contains two mezzanines. One unused mezzanine, referred to as Mezzanine 1 in this report, between gridline A-F and 15-17 is framed with wood and was part of the original building construction. A second steel framed mezzanine, referred to as Mezzanine 2 in this report, was added in the late 1980s, located between gridline J-L and 1-11. (Refer to Figures 2 and 3 for grid line references)

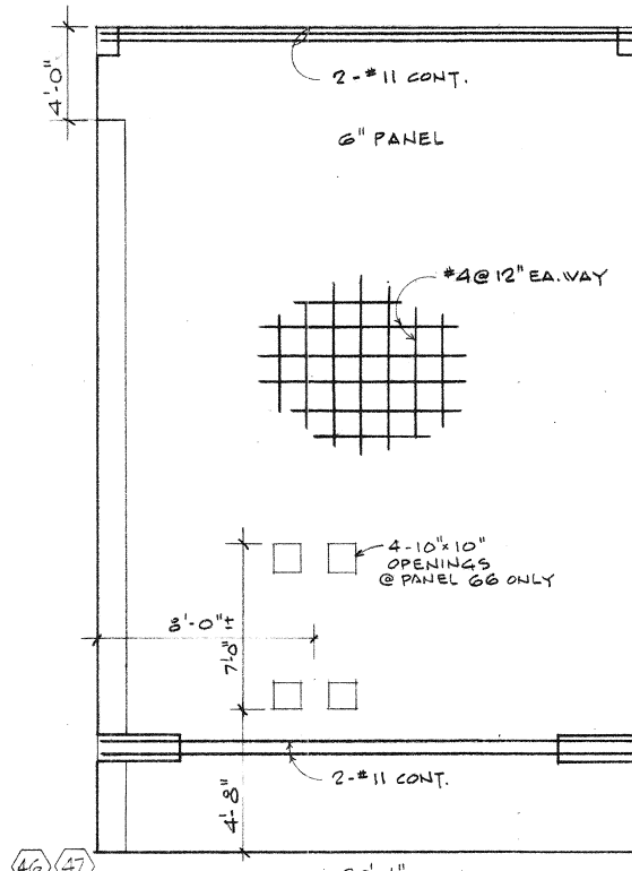
Figure 5 - Typical Panel Elevation

- Continuous chord elements are provided at the top of the panel (rather than at the roof level) by a 7” double sided fillet weld between a #11 bar and angle. The location of the chord above the roof framing may result more damage at the roof level.

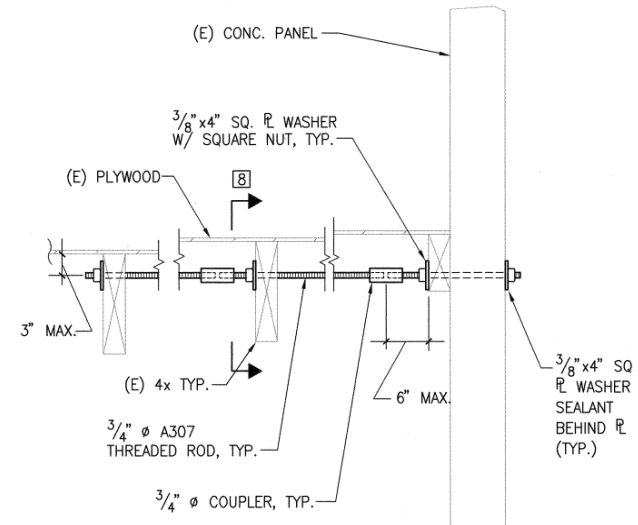
1998 Renovation - 2 additional out of plane wall anchors added between Glulam Beams
