DATE: 2019-11-18

UCSF building seismic ratings
Mount Zion Cancer Center Building H

CAAN #3004
1600 Divisadero Street, San Francisco, CA 94115
UCSF Campus: Mount Zion

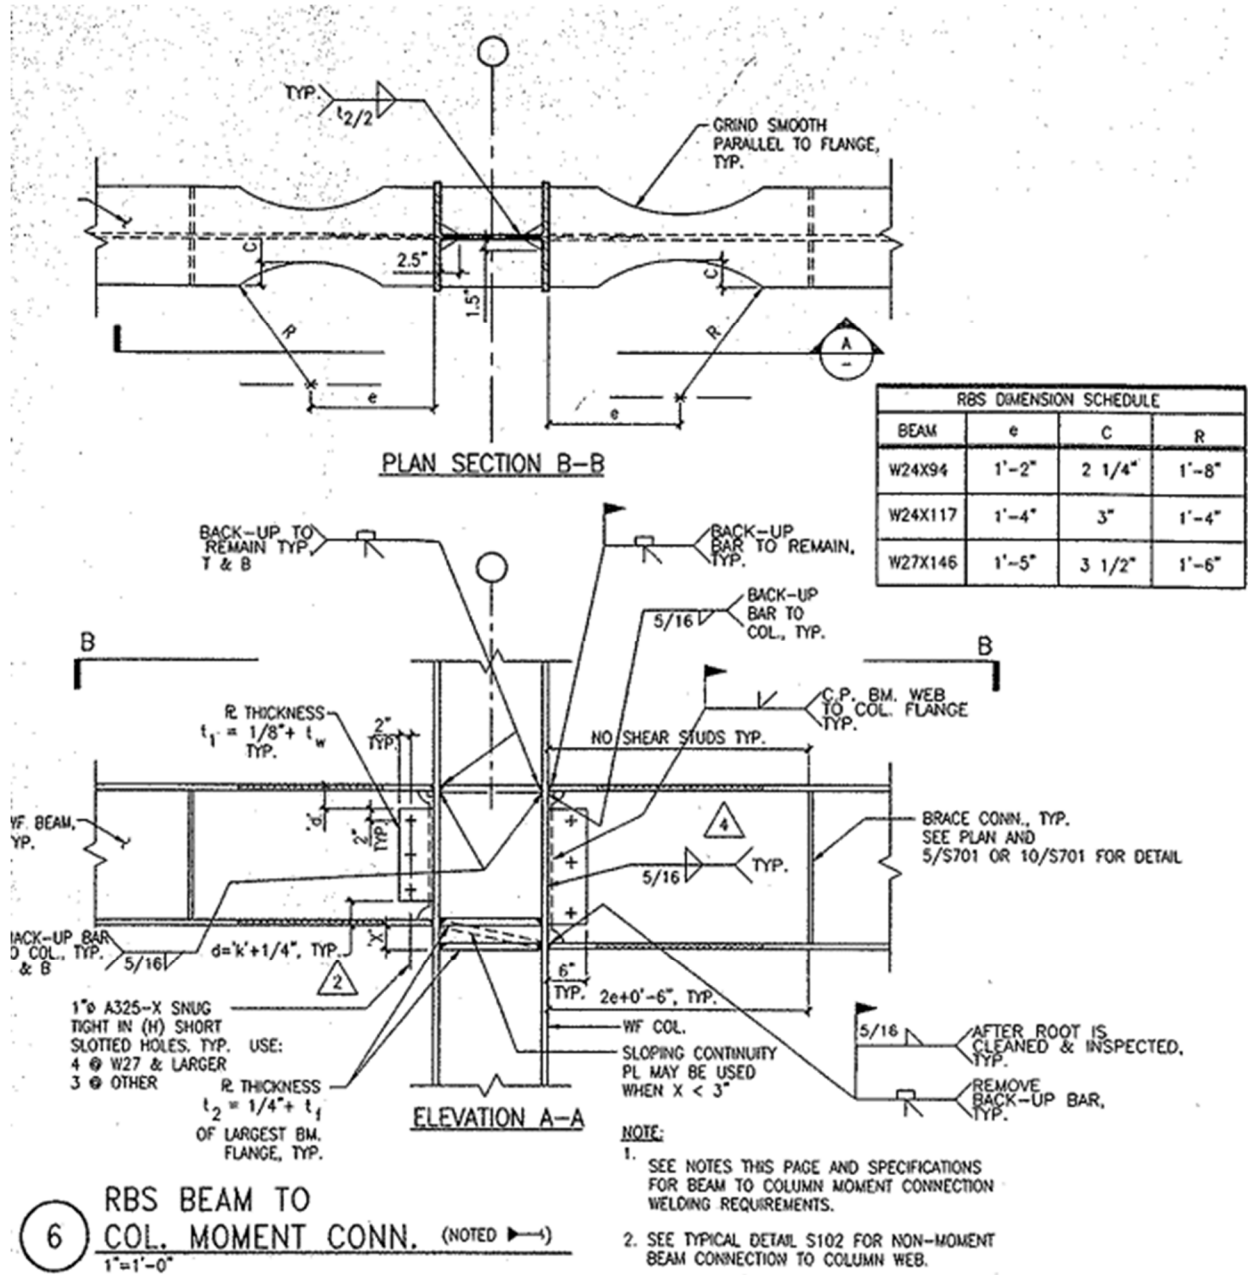
Typical reduced beam section (RBS) moment frame detail

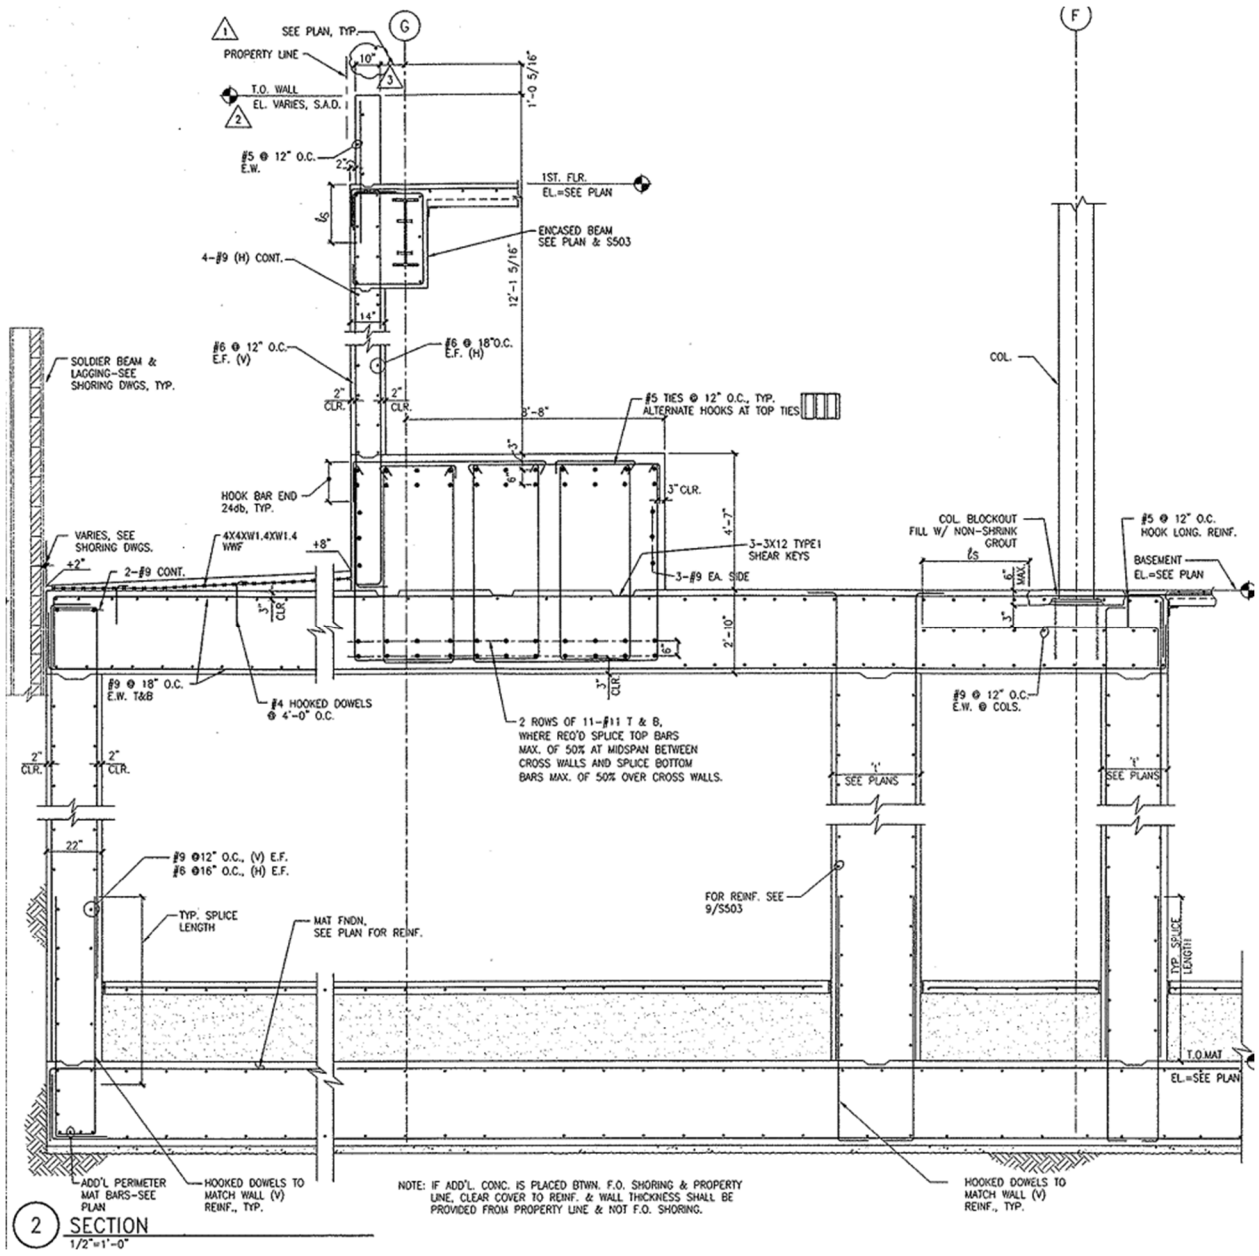
Section of the radiation room at the basement floor

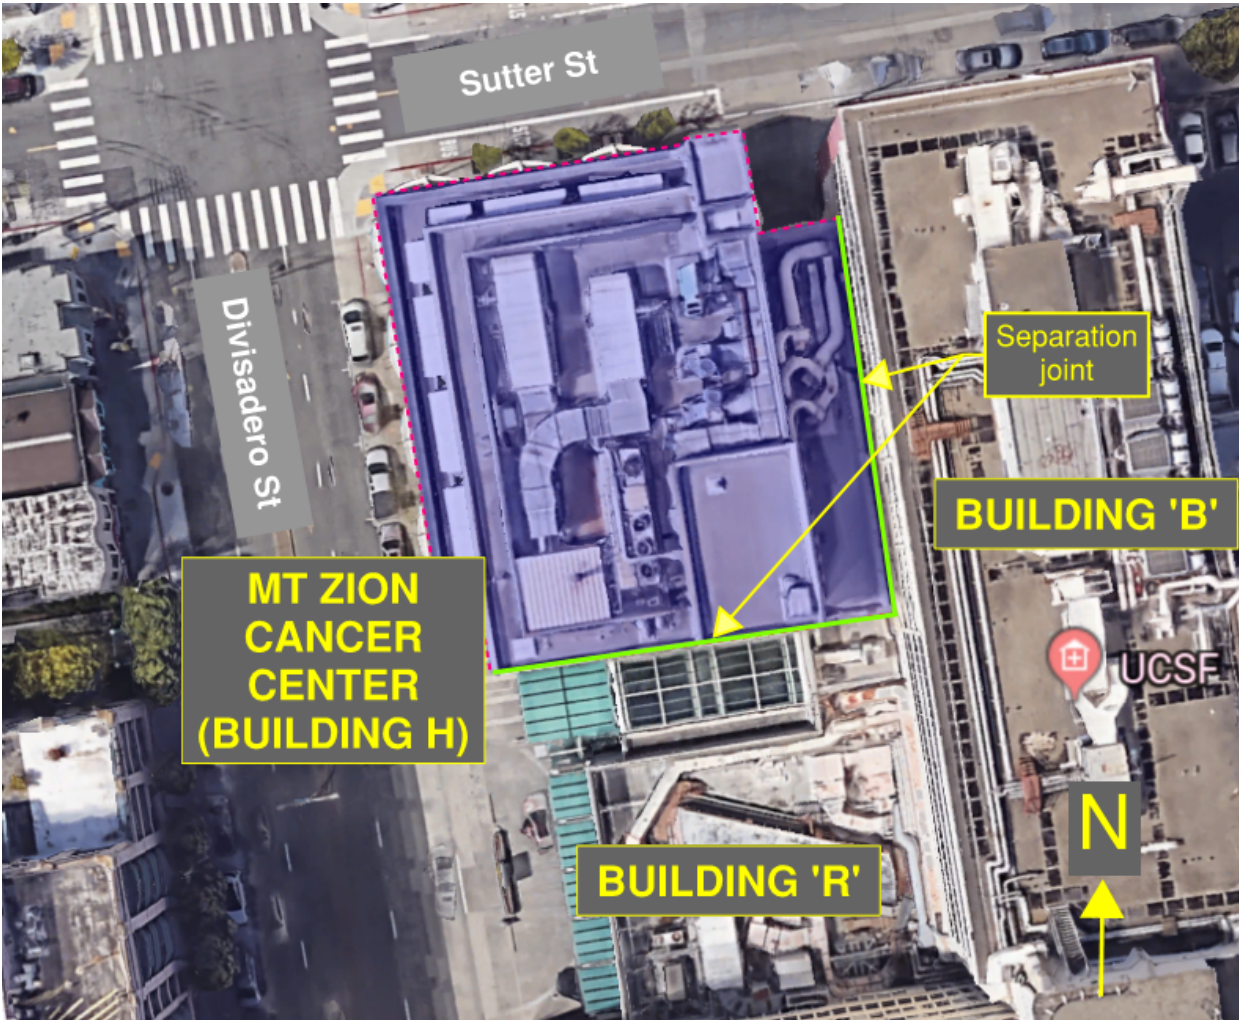
- The structure may contain inadequate seismic separation from adjacent buildings. The provided gap does not meet the ASCE 41-17 criteria of 1.5% times the story height. The provided gaps are 1", 2", 4", and 6", and the required gaps are 2", 4.14", 6.5", and 8.82" at the corresponding floor levels.

Adjacent buildings to the Mt. Zion Cancer Center

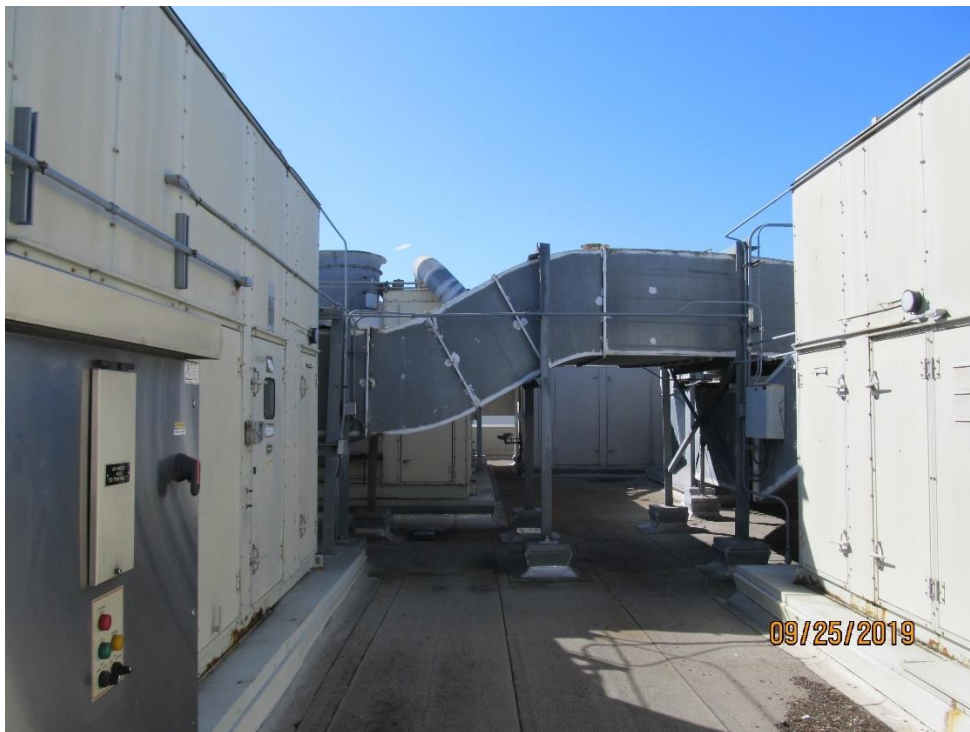
Building condition: Good. No on-going maintenance problems were noted by the building administrator. The roof and roof-top mechanical equipment are showing signs of age as some equipment housing, anchors, and skids are severely corroded.

Equipment at the roof (looking south)

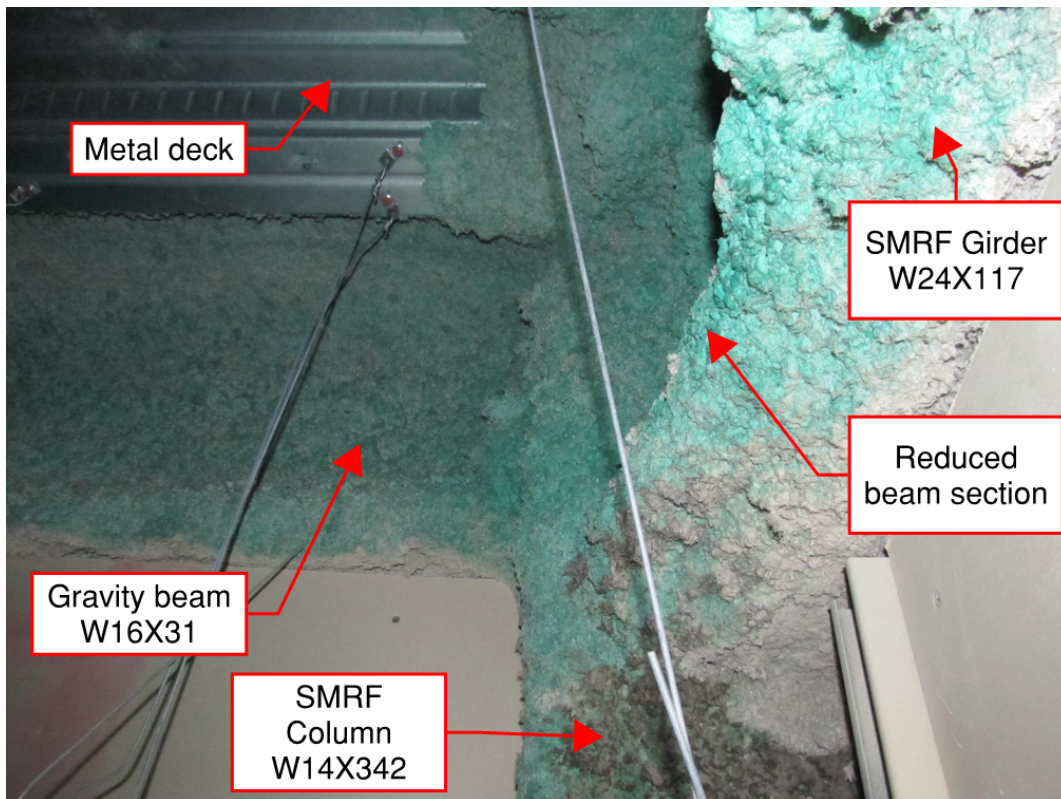
Reduced beam section moment frame connection with fireproofing located on the underside of the third floor (looking southwest with the RBS in the foreground)

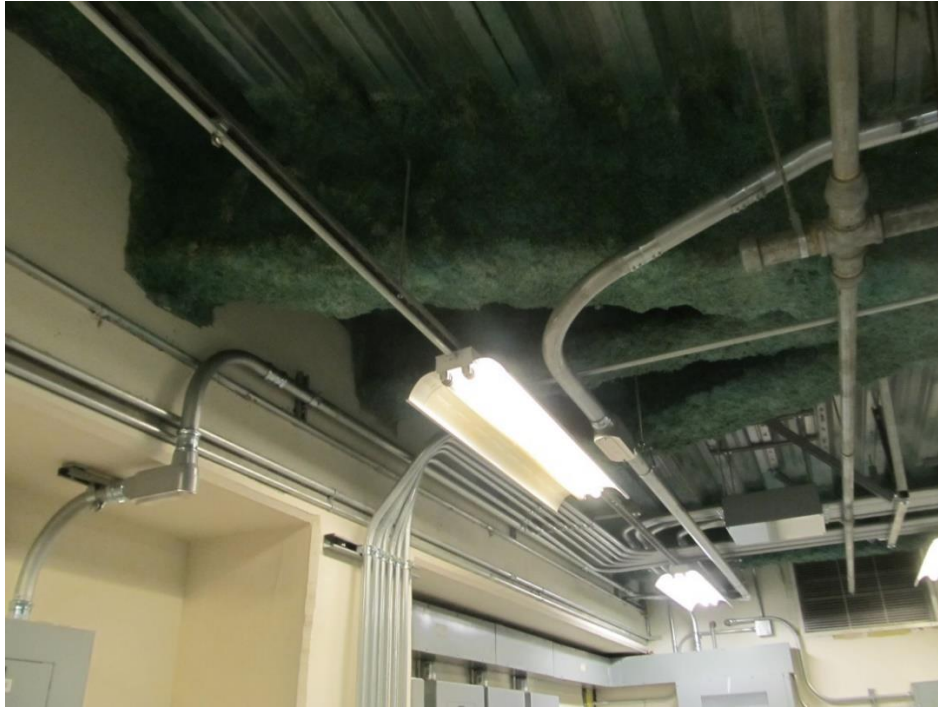
Diagonal steel framing encased in fireproofing provided for lateral bracing of the moment frame beam on the underside of the first floor (looking north)
