## UCSF Building Seismic Ratings

### Central Utilities Plant, Parnassus Avenue

CAAN# 3006

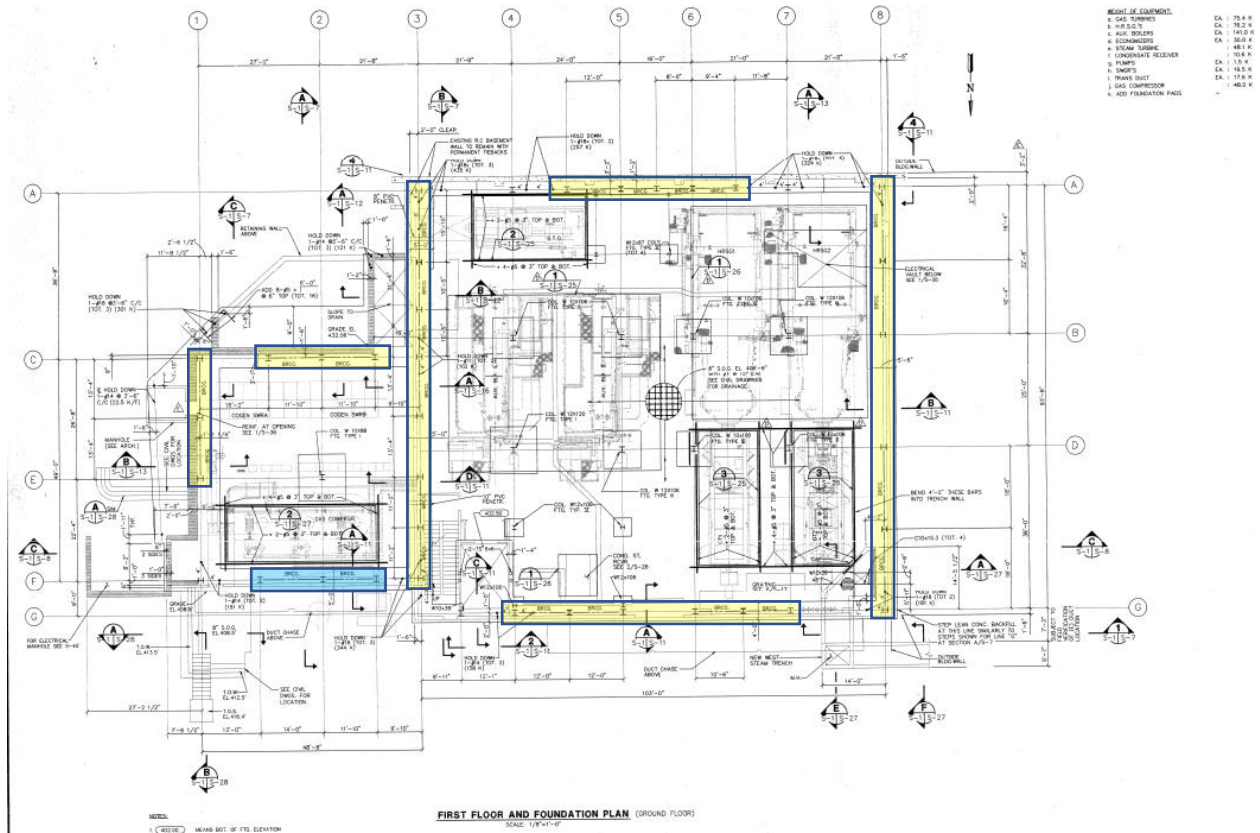
Building Foundation Plan (yellow rectangle indicates multi-tier braced frame; light blue rectangle indicates single-tier braced frame)

Foundation bearing demands exceed the soil capacity at Gridlines A, F, G, and 3.

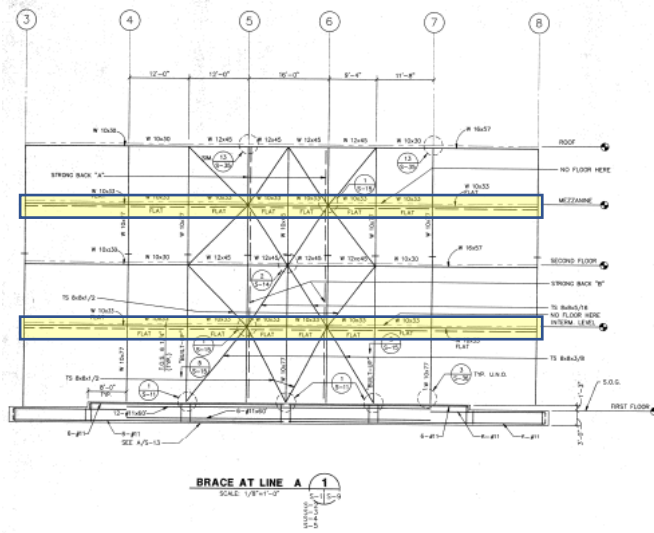
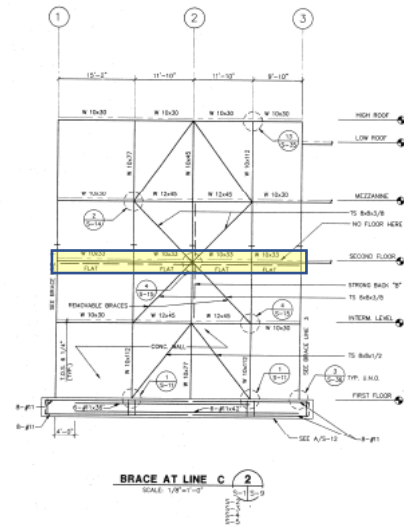
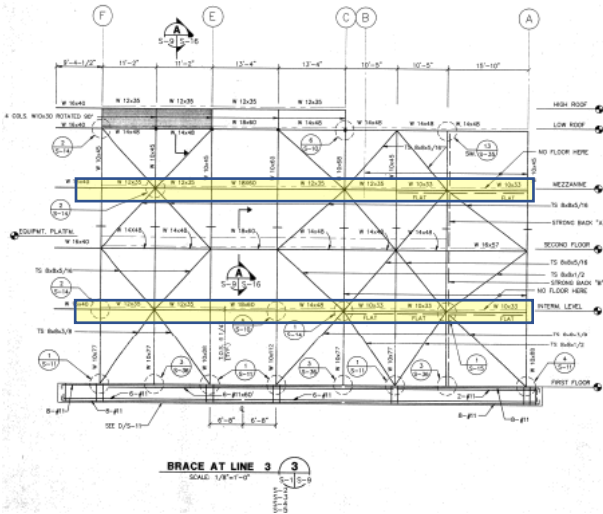
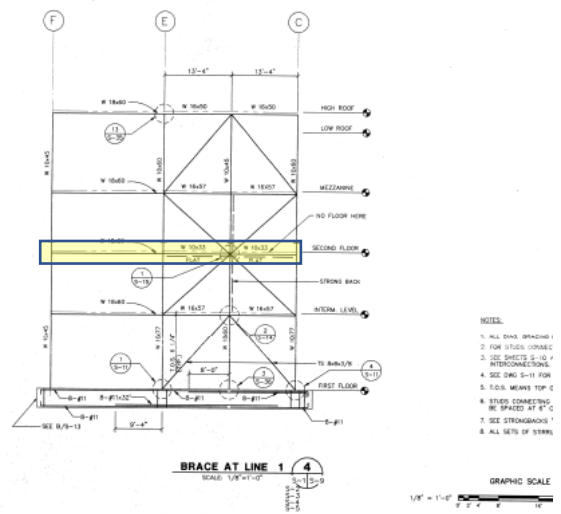
Building Braced Frame Section  
(yellow rectangle indicates location where no floor occurs – multi-tier braced frame)

- Seventy-seven brace elements fail the compactness requirements in accordance with AISC 341, Table D1.1 (TS 8x8x1/4, TS 8x8x5/16, TS 8x8x3/8 sections)
- Column axial stresses under gravity loads exceed the Quick Check limit of  $0.1F_y$ . However, all columns were found to have Acceptance Ratios below unity for Tier 3 combined compression and flexural stress checks.
- Exterior cladding is attached to girts that span between columns and diagonal bracing.
- The braced frames along Gridlines 1, C and F have width/height ratios equal to 0.414 which is less than the Tier 1 Quick Check limit of  $0.6S_a$  (1.1). Soil bearing demands were found to exceed allowable capacities as noted below.

The items listed above may affect the seismic performance of the building because local failures may occur and negatively affect the global building performance. The braces with 1/4 in., 5/16 in. and 3/8 in. wall thickness exceed the b/t compactness limits for moderately ductile members per AISC 341. Thin-walled braces have reduced low-cycle fatigue capacity and reduced energy dissipation capacity as compared with those that comply with highly ductile compactness requirements of AISC 341. This could result in a concentration of damage and excessive drift in one story. While capacities of the elements may be acceptable, the anticipated low cycle fatigue failures for these HSS members may result in unacceptable damage for a critical facility.

The supplemental analysis indicates that three braces have AR greater than unity for the BSE-R (1.02, 1.06, 1.23) and three have AR greater than unity for the BSE-C (1.02, 1.05, 1.06). The majority of these are only slightly above unity and all are above unity as a result of the b/t ratios reducing the m-factors. A simple solution to this potential behavior condition is to fill the braces with concrete or locally reinforce the braces with plates at the plastic hinge locations.
