UCSF Building Seismic Ratings

EH&S Annex Building (West)

CAAN# 2234A

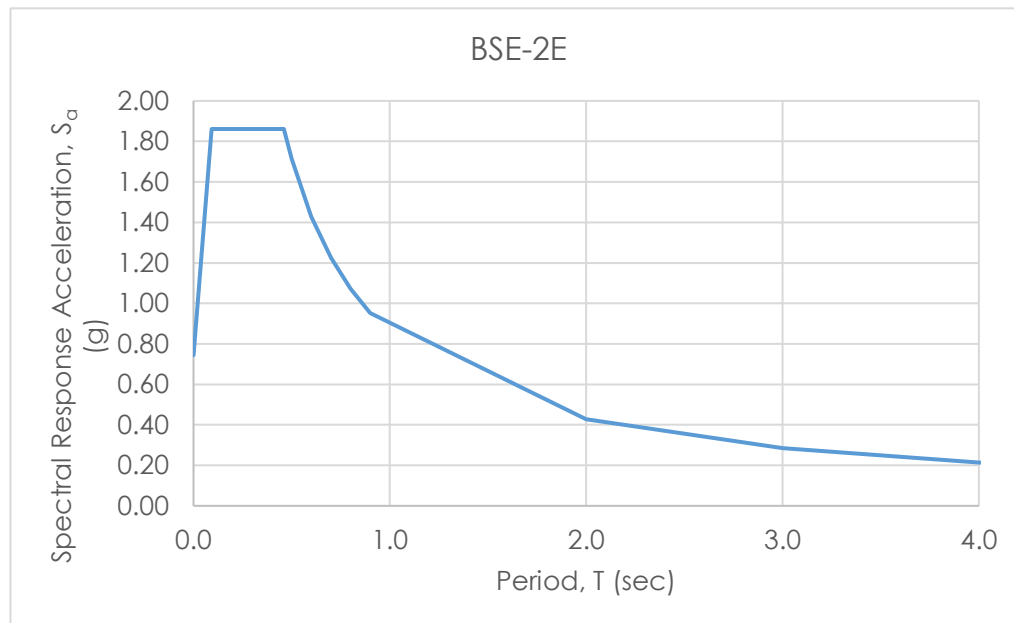
MCE _R ground motion (period=0.2s)	S _S	1.551 g
MCE _R ground motion (period=1.0s)	S ₁	0.612 g
Site amplification factor at 0.2s	F _a	1.2
Site amplification factor at 1.0s	F _v	1.4
Site modified spectral response (0.2s)	S _{X5}	1.861 g
Site modified spectral response (1.0s)	S _{X1}	0.857 g
Long-period transition period (s)	T _L	12 sec
	T ₀	0.092 sec
	T _S	0.460 sec

T	S _a
sec	g
0.0	0.744
0.092	1.861
0.460	1.861
0.50	1.714
0.60	1.428
0.70	1.224
0.80	1.071
0.9	0.952
2.0	0.428
3.0	0.286
4.0	0.214
6.0	0.143
8.0	0.107
10.0	0.086
12.0	0.071
