**FORM 1**  
**CERTIFICATE OF SEISMIC PERFORMANCE LEVEL**

Building Name: Health Sciences Instruction and Research East  
Address: 513 Parnassus Ave., San Francisco  
Site location coordinates: Latitude 37.7623 Longitudinal -122.4577

**UCOP SEISMIC PERFORMANCE LEVEL (OR "RATING"): IV**

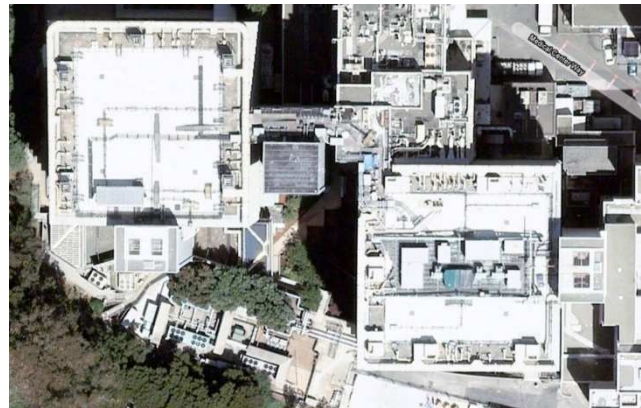
**Figure 5: HSIR building satellite view.  
©2009 Google, ©2009 GeoEye**

The Health Sciences Instruction and Research complex is located on the north slope of Mt. Sutro at the Parnassus Campus of the University of California, San Francisco. Designed by the Reid Rockwell Banwell and Tarics Architects and Engineers, and first occupied in 1966, the buildings are located on Medical Center Way, adjacent to the Medical Sciences Building, the Parnassus Services Building, and the recently constructed Institute for Regenerative Medicine. The Health Sciences complex consists of five seismically separate buildings including an elevator tower and corridor, and two laboratory buildings, each with its own mechanical utility tower supplying heating and ventilation. See Figure 4 and Figure 5.

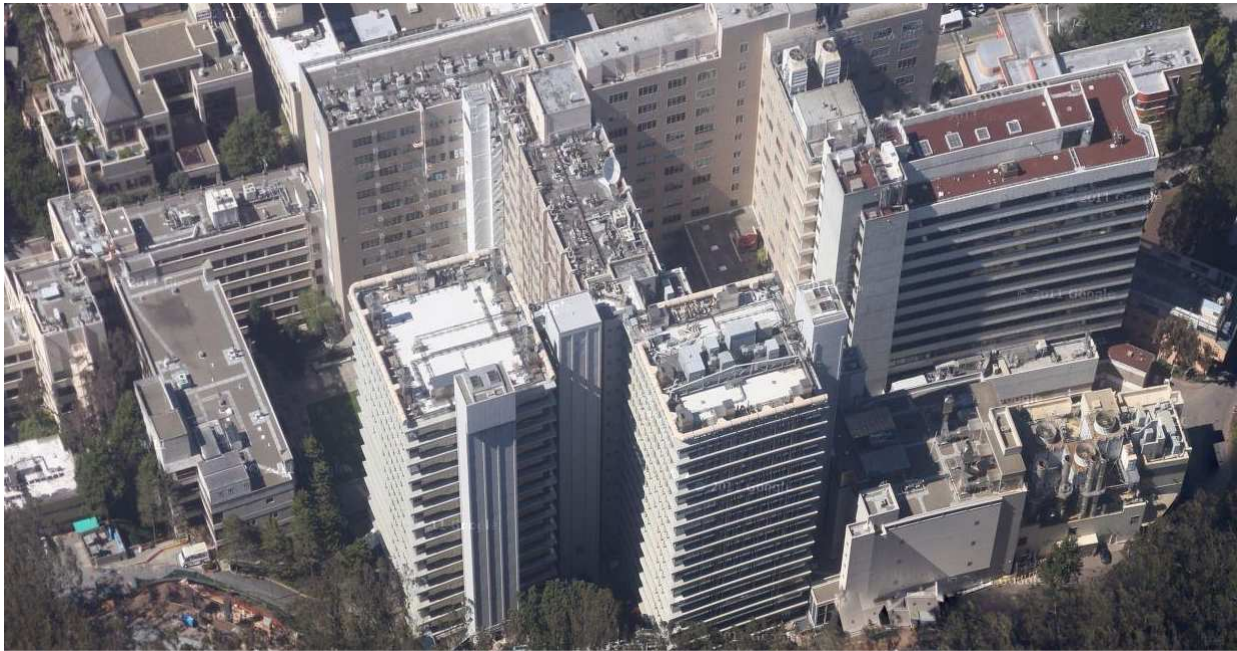
**Figure 6: View of Health Sciences building complex and adjacent buildings. © 2011 Google**

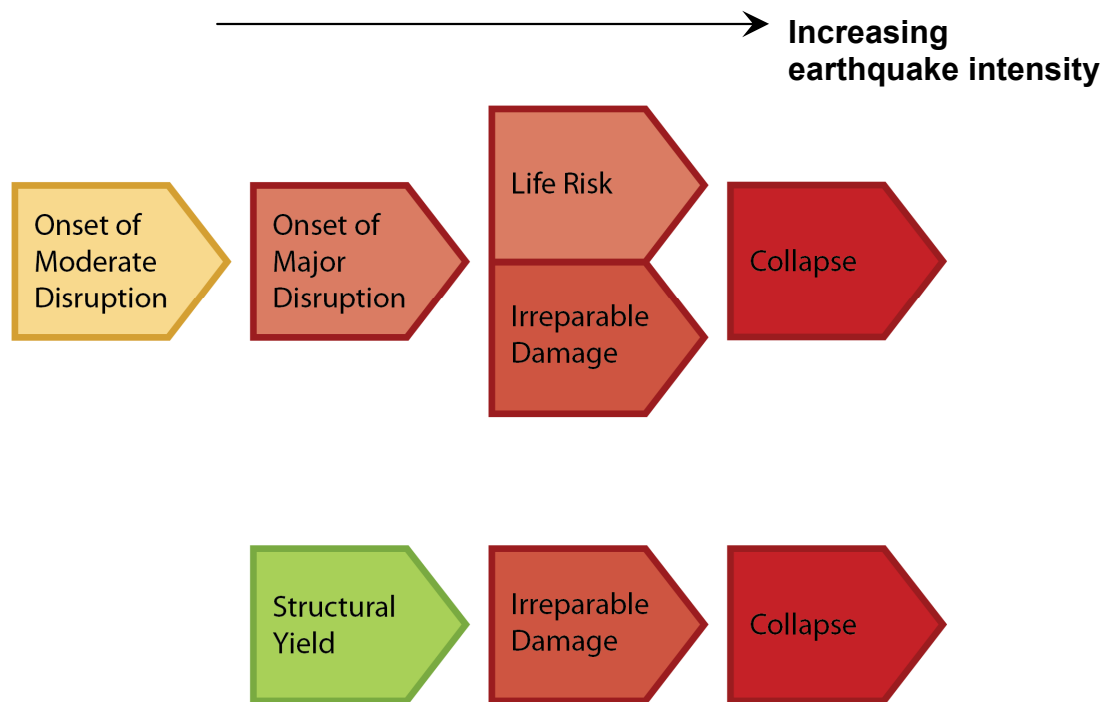
**Figure 8: Chart showing the hierarchy of project-specific performance levels used in the HSIR evaluation.**

The bottom of Figure 8 shows, on a separate track, the hierarchy of performance states that depend solely on structural behavior. For the HSIR structure to become irreparable, we expect that it would have to deform well beyond yield. Thus *Onset of Structural Yield* is shown occurring before *Onset of Irreparable*

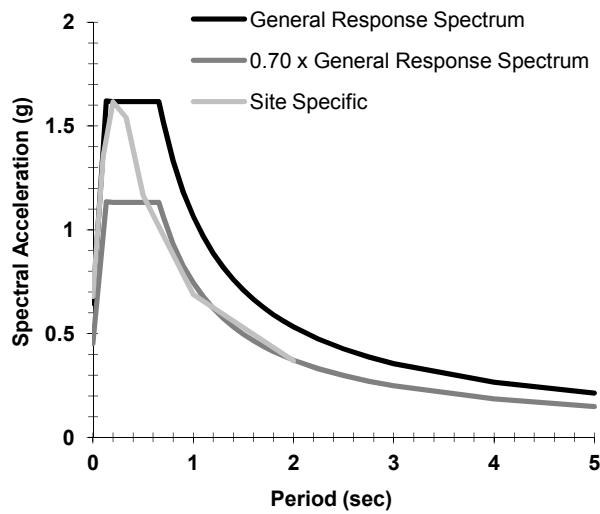
**Figure 11: 975 year mean return period General Response Spectrum per ASCE 41-06. Also plotted is the site-specific 975 year response spectrum.**

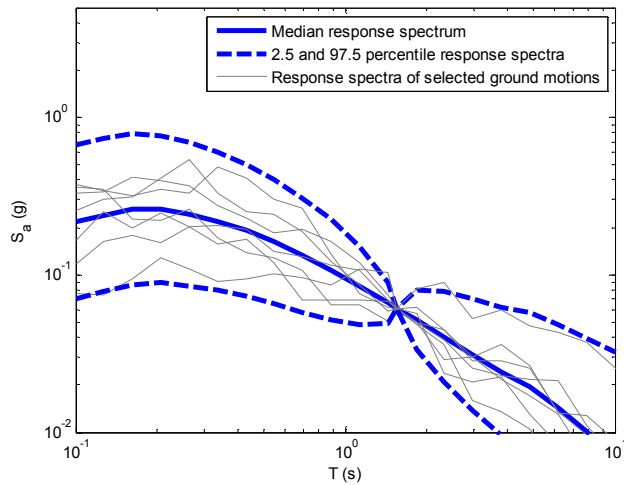
Figure 13: Plot of conditional mean spectrum and response spectra of ground motions selected at the 72 year return period.

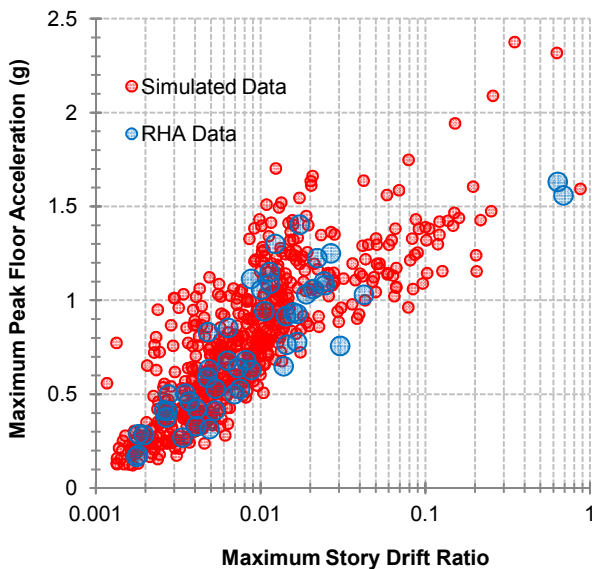
**Figure 21: Plot of maximum interstory drift ratio and maximum peak floor acceleration data from response-history analysis and Monte Carlo simulation. The points at the far right represent structural collapse caused by large earthquake ground motions.**

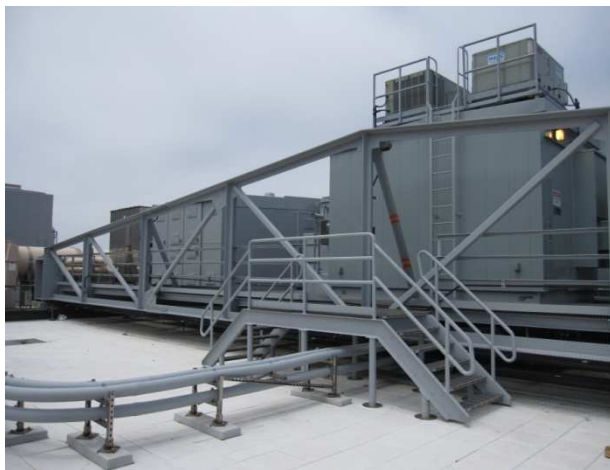
**Figure 26: HSE roof equipment bridge and equipment.**

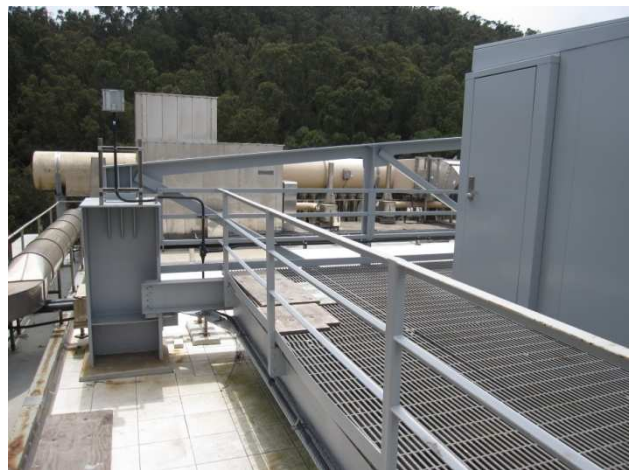
**Figure 27: HSE roof equipment bridge column support.**

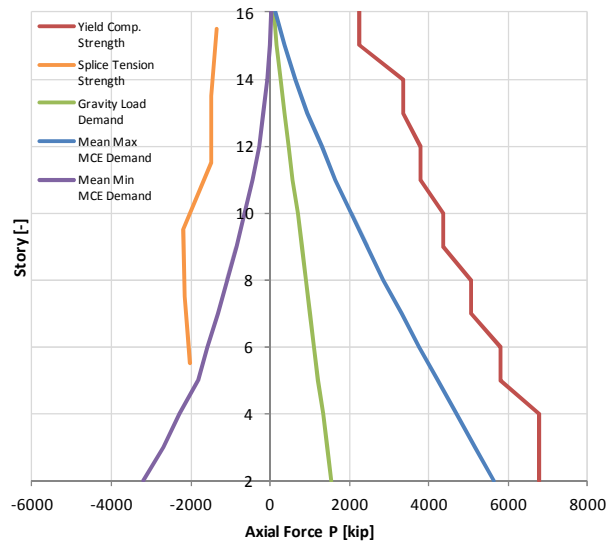
**Figure 28: Corner column and corner column splice axial strength compared to MCE demands.**

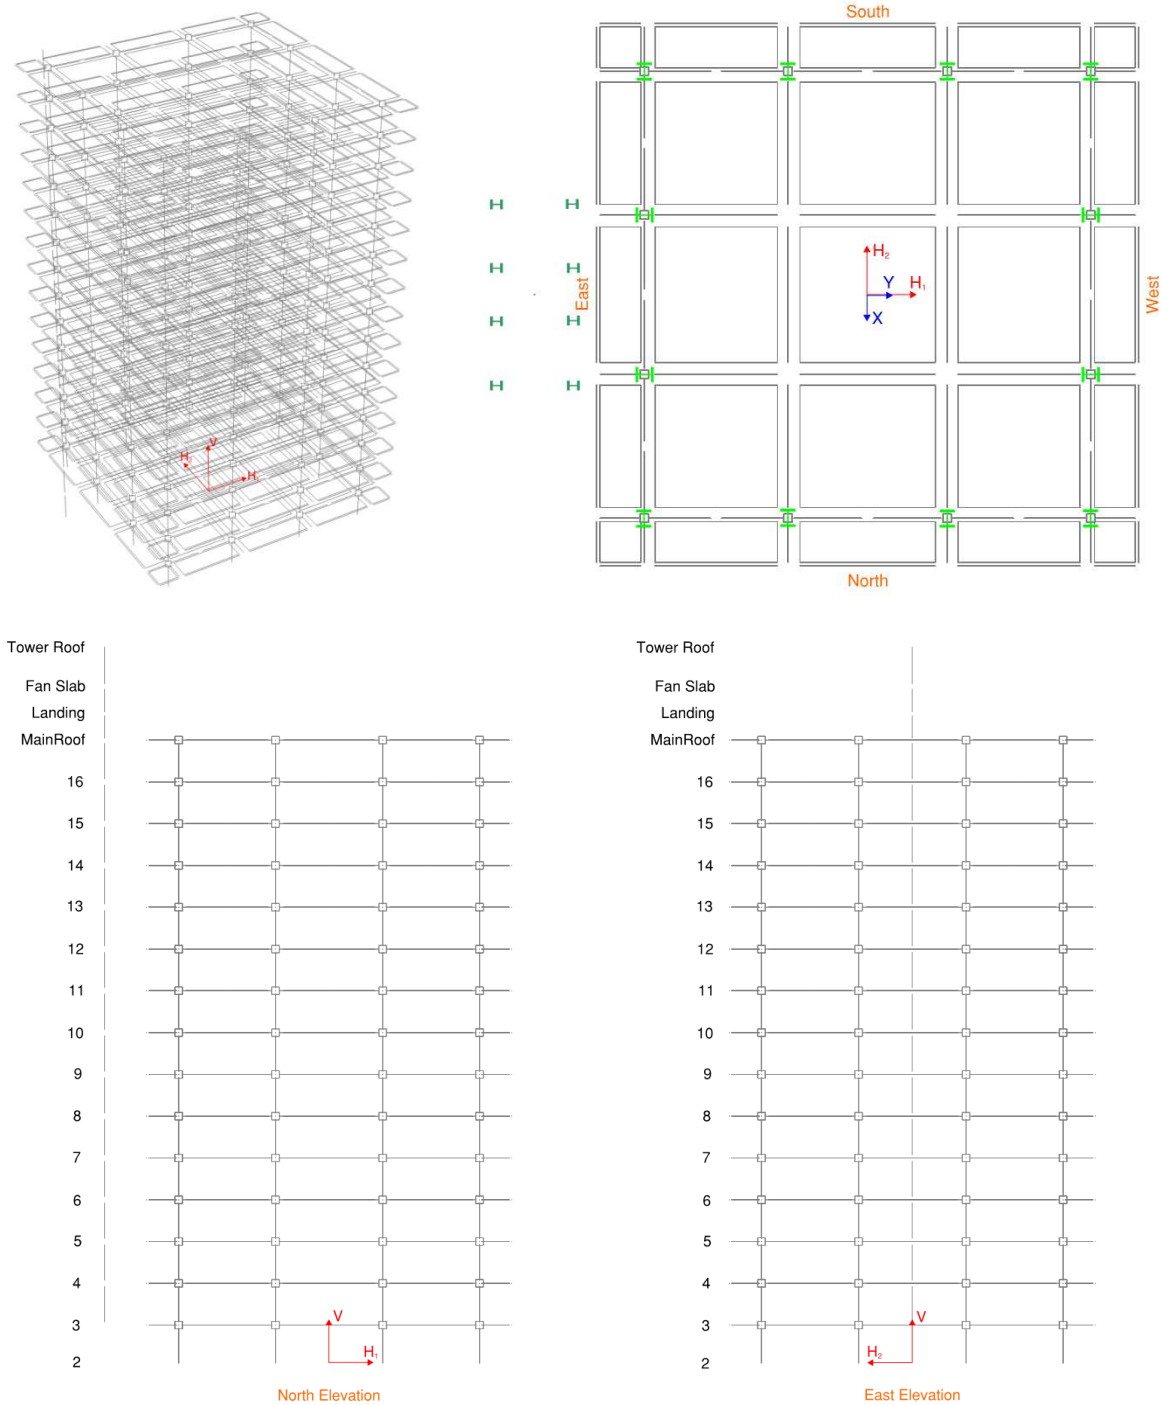
**Figure 46: Perspective, plan and elevation views of the Perform-3D model.**

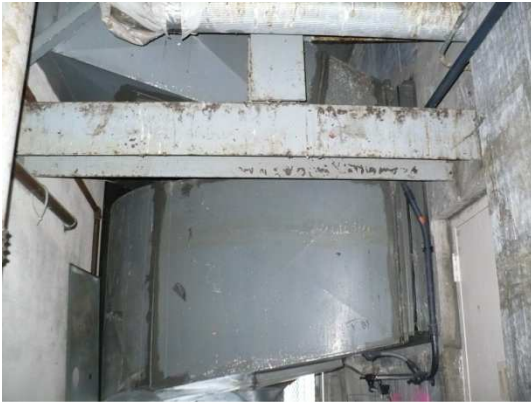
**Figure 80: Typical floor main ductwork crossing the separation joint between the stair tower and HSE or HSW.**

Each floor of the Tower building is supplied by two supply air duct risers with 6 fixed branch ducts. Figures 1 and 2 in Appendix C show a typical floor main supply and exhaust air duct distribution for old and newer (remodeled) floors. Due to the depth of the steel structure, the 6 main floor supply ducts are routed through pre-cut openings in the steel girders. The main supply duct branch exits the stair tower supply air shaft and crosses the separation joint between the building and the stair tower. The main duct penetration through the shaft wall is equipped with fire/smoke dampers which were installed as part of the air handling system upgrade project, and a flexible duct connection (with about 1-inch gap between the duct through the stair tower shaft and the building duct). See Figure 80 and pictures PT-9 and 10 of Appendix C. The gap for the flexible duct is not large enough to accommodate the building movement in an earthquake. Due to the duct configuration and available space in the building separation joint, it is not practical to install a flexible duct joint in the main supply duct exiting the riser shaft, to overcome the seismic movement of the building. Because of this, we recommend that UCSF prepare a procedure to repair or replace the duct in minimal time in the event of an earthquake.

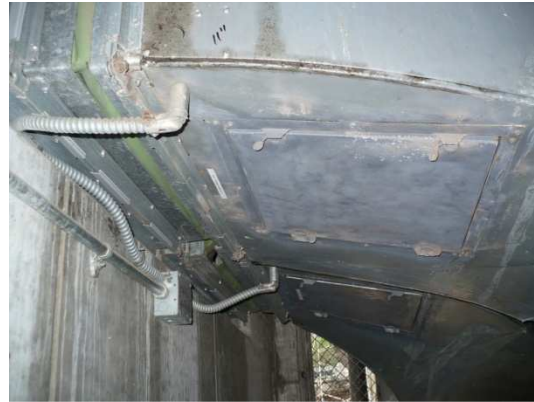
**Figure 81: Typical duct penetrations through stair tower shaft.**

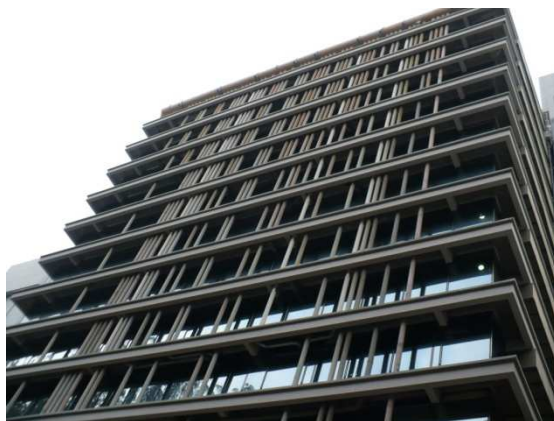
**Figure 82: Typical exterior fume exhaust duct risers - HSE south face.**

Each fume hood from a typical floor is ducted to the exterior of the building, penetrates through the building window glazing, and rises up through a pre-punched hole on the building ledges to the roof. Figure 82 and Figure 83 and Pictures PT 1 and 2 in Appendix C show the typical fume exhaust duct risers in HSE and HSW. The portion of the fume exhaust duct indoors is constructed of type 316 stainless steel. The fume exhaust duct outdoors is constructed of fiberglass-reinforced plastic. The transition of material occurs after the duct penetrations through the building window glazing. The pre-punched holes on the ledges were sized to accommodate a 9-inch duct with about 1/2 inch annular space, which is filled with caulking material. The existing duct penetration openings through the floor ledges were notched, such that the duct risers on the upper floor rest on ledge and the duct from the lower floor riser penetrates the ledge and clip in to the upper floor duct. Newer duct penetrations were cut as one size holes. Short pipe clamps were used to support the duct risers at each level. Figure 84 and Figure 85 and Pictures PT-3 through 8 show the typical fume exhaust duct riser construction and arrangements.

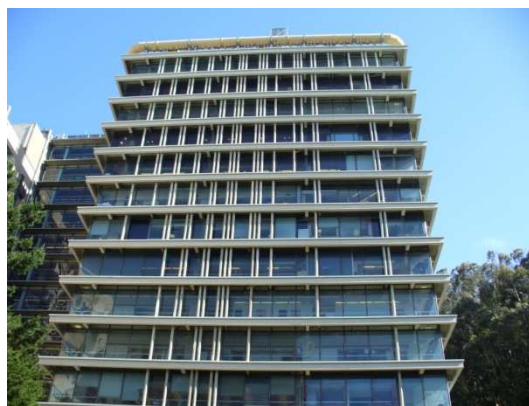
**Figure 83: Typical exterior fume exhaust duct risers – HSW north face.**

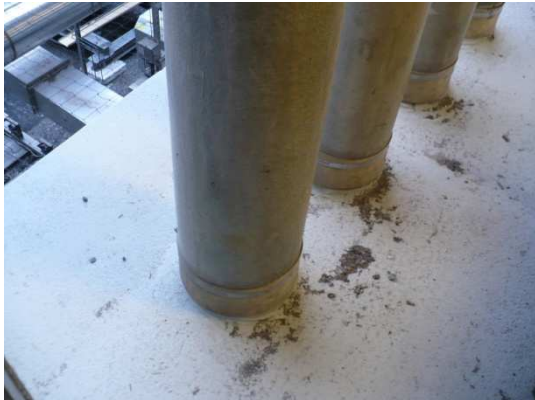
**Figure 84: Typical multiple fume exhaust duct risers through the ledge.**

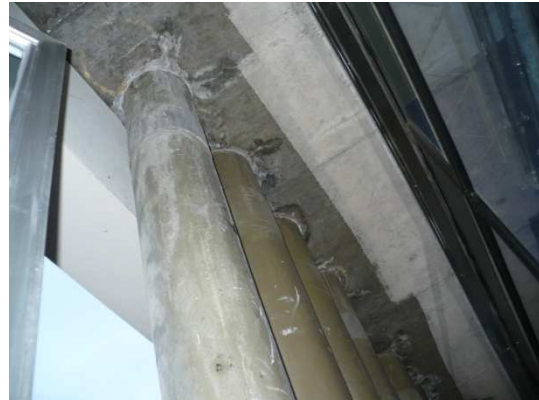
**Figure 85: Typical multiple fume exhaust duct risers through the ledge above.**

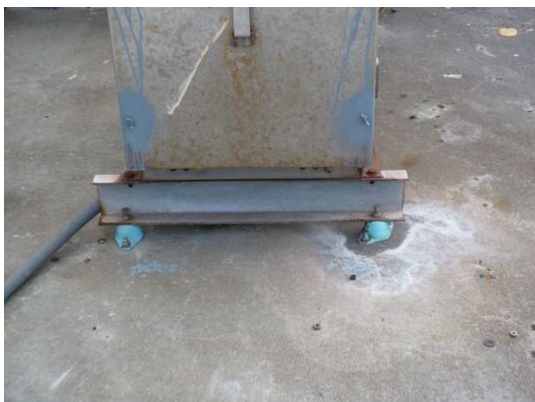
**Figure 86: Typical fume exhaust fan HSE with un-restrained rubber isolators.**

Some special fume hoods or biosafety cabinets are exhausted by independent individual small fume exhaust fans located on the roof. These fans are mounted on base rails and vibration isolators. The fans on HSE roof are supported by two kinds of vibration isolators. The older fans (pre-1998 building code) are mounted on rubber in shear (Mason ND), while the new fans are mounted on base rails with open spring vibration isolators and seismic snubbers or housed spring vibration isolators. The fans on HSW are mostly supported by restrained, double sphere, neoprene rubber (M.W. Sausse Model FUD) isolators. A few fans are supported by housed spring vibration isolators or open spring with seismic restraints. Pictures PT 26, 27, 29, and 30 in Appendix C show the typical small fume exhaust fan support. The small fans on HSE that are mounted on rubber, in-shear isolators do not have seismic restraint capability. These should be replaced with new seismic restraint isolators.

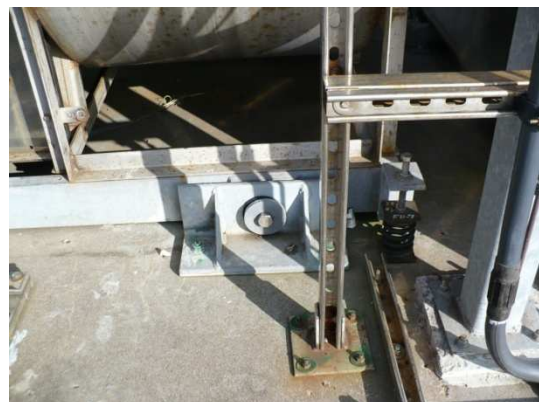
**Figure 87: Typical manifolded fume exhaust fan base frame with spring vibration isolators and snubbers.**

housed spring vibration isolators. HSW manifold fume exhaust fans are mounted on a base frame with unhoused spring isolators and seismic snubbers.

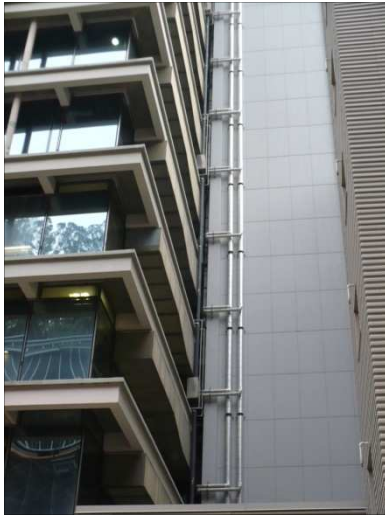
**Figure 88: New HSE HHSW/R risers (2000) – south face of stair tower.**

Heating hot water is generated in each building (HSE & HSW) via two steam-to-hot water heat exchangers, and three hot water circulating pumps in HSE and two pumps in HSW. The equipment is located in the lowest level of each building tower. The heat exchangers are existing original units, installed in 1963. The heat exchangers are mounted on a base frame with a small diameter pipe leg at each corner of the frame. See pictures P1I and P1J in Appendix C. The support for the heat exchangers should be upgraded to meet the current code. The hot water circulating pumps and the piping infrastructure were replaced and upgraded in 2000 and 2005 in HSE and HSW, respectively. The heating hot water pumps are anchored directly to the concrete housekeeping pad. The heating hot water system is currently serving the main supply fan preheat coils, zone reheat coils, and the existing perimeter baseboard heaters. Heating hot water supply and return piping are distributed throughout the building with the pipe risers located in the stair towers and two corners of the floor. Figures 3 and 4 show a typical floor arrangement of the pipe risers and distribution in the older and newer (remodeled) floors, respectively. Heating hot water pipes from the stair towers exit the pipe riser shaft, cross the building separation joint, and enter the building. There is currently no pipe separation joint expansion compensation. The years 2000 and 2005 hot water system upgrade included the installation of new additional heating hot water supply and return risers mounted on the exterior face of each HSE and HSW stair tower respectively with branch stub-out at each floor (starting from Level 4 and up) to provide supplemental heating hot water to each floor. Figure 88 and Pictures PT 31 and 32 in Appendix C show these risers. In addition, new heating hot water mains were also routed through building seismic gaps. In an earthquake, these pipes may be crushed by the two buildings, or break by the excessive building movements. This condition needs to be corrected by locating the pipe risers outside the building seismic gap and flexible piping.

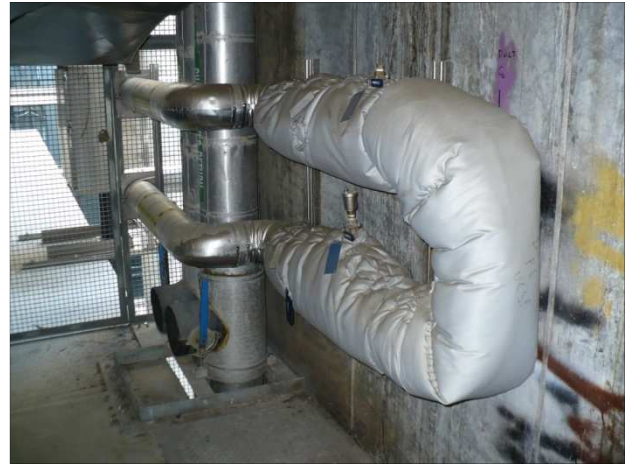
**Figure 89: Typical floor chilled water risers through seismic gap with valve stub-outs and heating hot water sub-outs in building gap between stair tower and HSE or HSW.**

The primary source of chilled water for the HSIR buildings comes from the central utility plant. There was a backup air-cooled chiller farm located on Hooper pad which could supply chilled water to HSW tower or back-feed the central chilled water loop. The back-up air-cooled chillers are no longer in use and were abandoned in place. The chiller farm equipment will not be evaluated, because it will be removed in the near future. Twenty-four-inch diameter chilled water supply and return pipes exit the central utility plant and distribute chilled water to the PSB, MSB and HSIR buildings. Sixteen-inch chilled water supply and return piping enter the east side of the HSE tower at Level 1 and run along the Level 2 south breezeway, rising up to Hopper pad (Level 4) to the HSW tower. Each tower building has its own VFD-driven tertiary pumps (3 in HSE and 4 in HSW) which distribute chilled water to the main air handling system cooling coils, duct-mounted cooling coils, and fan coil units in the tower floors. Chilled water supply and return piping rise next to the stair towers of HSE and HSW inside the building separation joint, and branch out at each floor. Figure 89 and Picture PT24 in Appendix C shows a typical chilled water pipe riser in the building seismic gap. These risers need to be relocated to outside the seismic gap, possibly on the same stair tower face as the heating hot water risers. On the 8th floor, there are 6" CHWS/R pipes that originate from HSW chilled water pipe risers and run around the east corridor of HSW, and cross the elevator tower into HSE and MSB buildings. See Drawing M8 in Appendix C. These pipes were installed between 1992 and 1993. This set of chilled water pipes crosses a number of building separation joints. This should be minimized or corrected. For correction measures, we recommend separating the chilled water distribution from HSE and HSW, and supplying the HSE part of the building from HSE chilled water risers. New pairs of chilled water risers are required, or larger pipe risers should be installed as part of the relocation work of the existing pipe riser work.

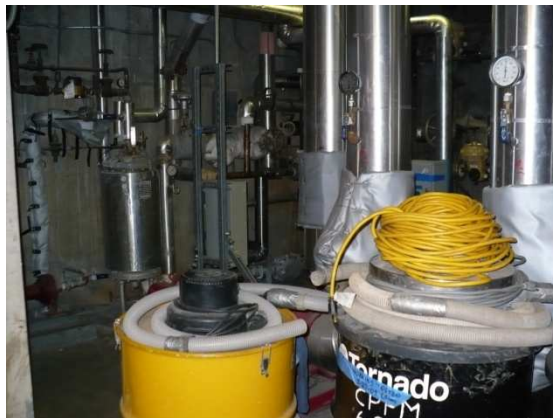
**Figure 90: HSE 1st Floor Mechanical Room – domestic hot water generator.**

Industrial hot water in HSE is generated by two 350-gallon storage type steam-to-hot water generators located in the Level 1 mechanical room. This equipment is still original, installed in 1963. See pictures P1F and P1G in Appendix C. Industrial water heater in HSW is generated by two semi-instantaneous steam-to-hot water heaters located in the Level 2 mechanical room. See Figure 91 and Picture P2N in Appendix C. This equipment was installed in 2009. Industrial hot water is distributed throughout the building to serve the lab fixtures and equipment. The distribution system has a return loop and a circulating pump.

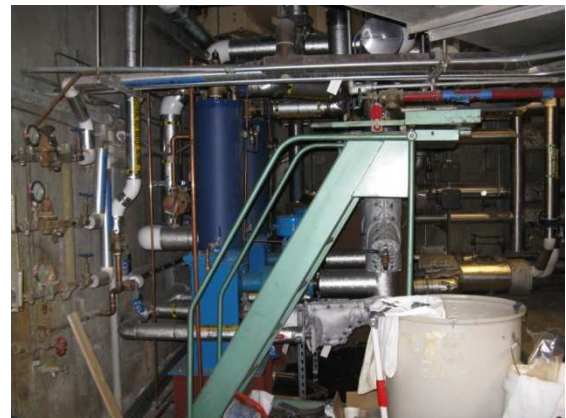
**Figure 91: HSW 2nd Floor plumbing room – industrial hot water generator.**

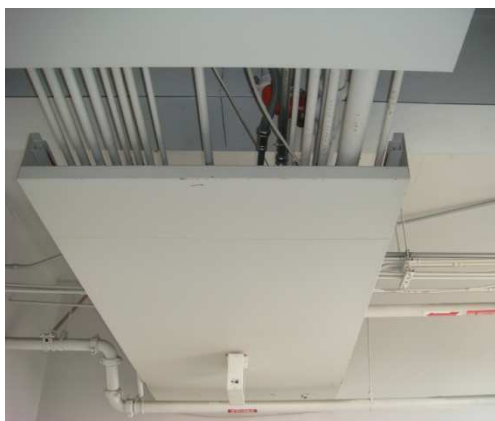
**Figure 92: Typical conduit routing between connecting corridor and laboratory building.**

- The cable tray system is continuous and does not include separation joints at key intersections and has limited flexibility to handle stresses during any type of separation joint motion. Cable tray retrofit should be considered during a *Target Loss Reduction* retrofit and has a low vulnerability during floor acceleration.

A simple and cost effective retrofit measure to limit the seismic vulnerability of this component during a separation joint motion moment would be to modifying the existing cable tray at the separation joints to provide slack in the components to accommodate seismic drift.

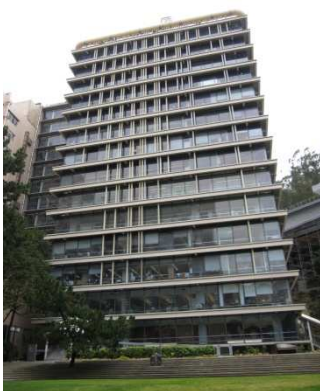
**Figure 96: Exterior view of laboratory building window glazing.**

The window glazing spans between floor slabs covering the exterior of each building. Mullions are typically spaced at 6'-6" horizontally, and the glass at each story is divided vertically into three separate panels. The largest panel is located in the middle, with a vertical span of 9'-4". The smaller top panel spans 1'-6" vertically, while the bottom panel spans 1'-1". According to the original design drawings, the window glazing is 1/4" plate glass secured with a continuous neoprene perimeter gasket. The vertical mullions of the curtain wall system have a unique steel truss design, formed by a bent round bar as shown in Figure 99.

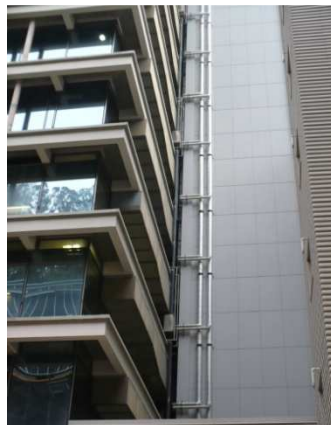
**Figure 97: View of window glazing a laboratory building corner**

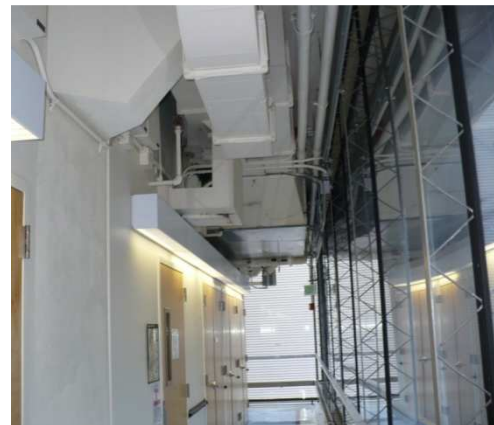
**Figure 98: Typical interior view of laboratory building window glazing.**

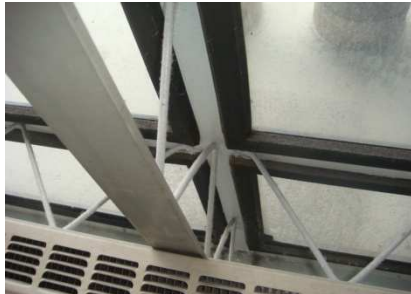
**Figure 99: Curtain wall open web mullion and neoprene gasket.**

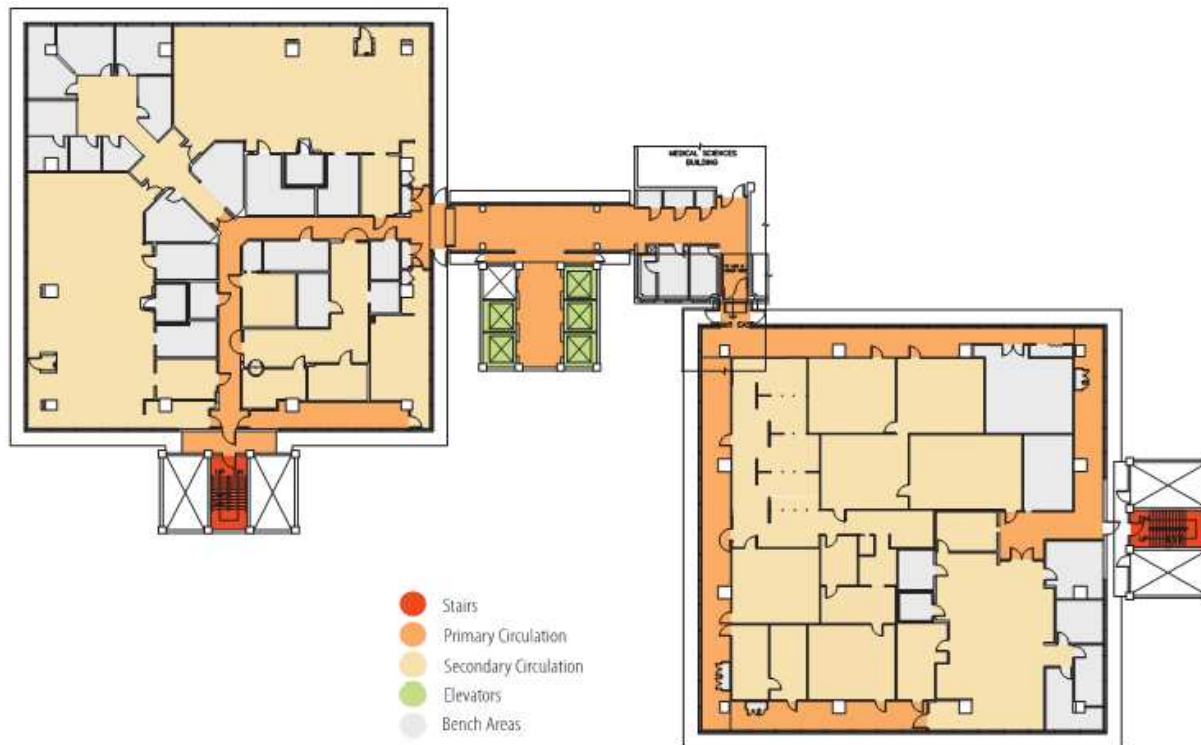
**Figure 105: Circulation diagram for a typical laboratory floor. The building utilities and infrastructure scope U0 protects the primary circulation path to the mechanical tower stairs.**

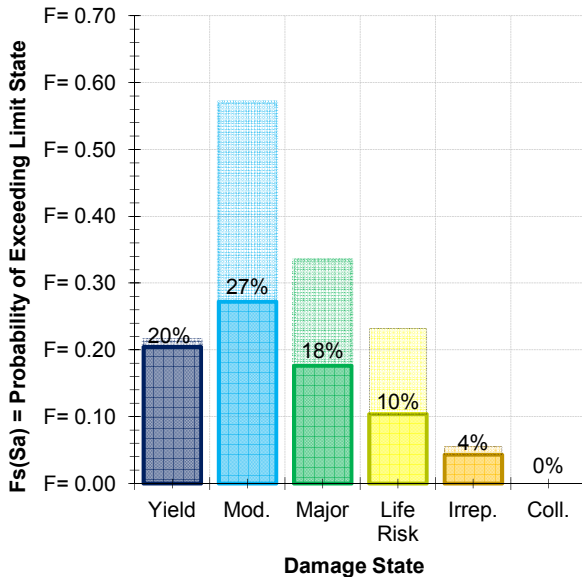
**Figure 112: Probability of reaching or exceeding project-specific performance levels for Retrofit Scheme I at least once over the next 30 years. The results for the existing building are shown as a light shadow for comparison.**

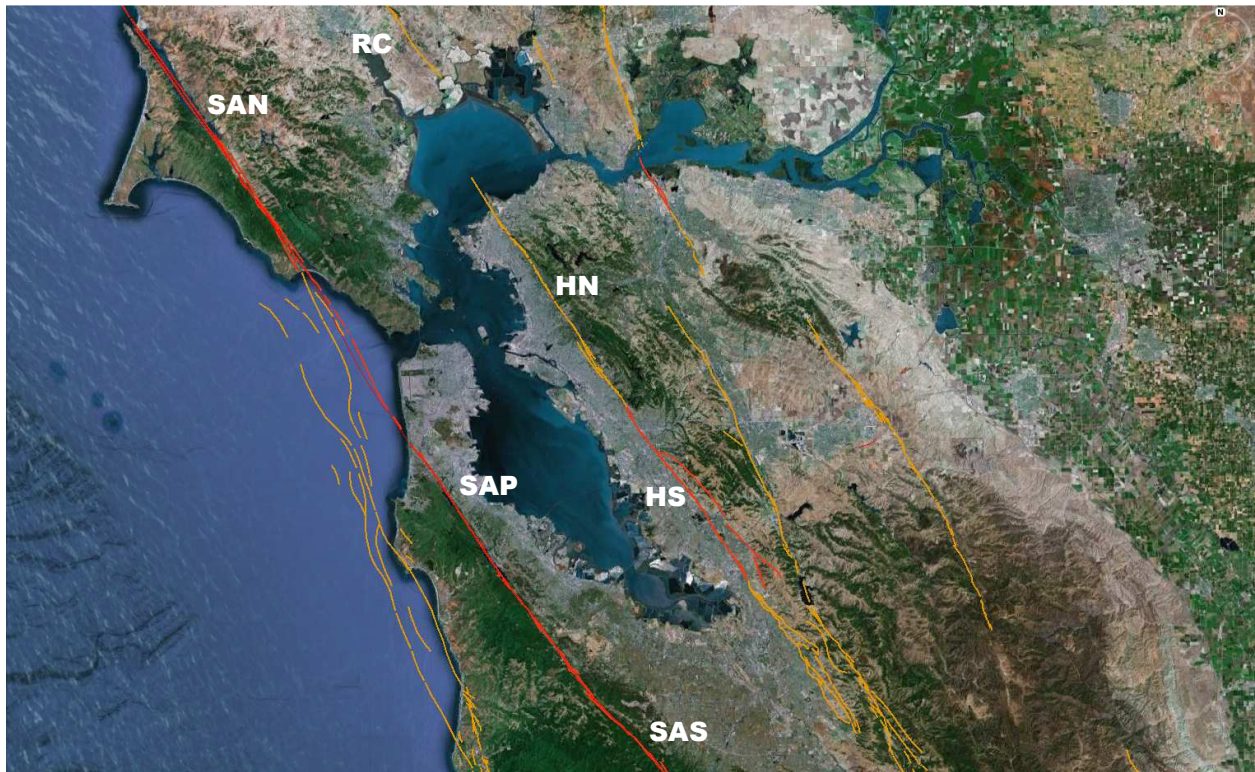
**Figure 123: Fault segments considered in the Hayward and San Andreas ground motion scenarios. Key for Hayward-Rodgers Creek scenario: HS = Hayward South, HN = Hayward North, RC = Rodgers Creek. Key for San Andreas scenario: SAS = Santa Cruz Mountains segment, SAP = Peninsula segment, SAN = North Coast segment, SAO = Offshore segment (not shown). © 2012 Google. © 2012 TerraMetrics**
